Building Condition Assessment

DNSSAB Temagami Ambulance Services Building
7 Stevens Road, Temagami, Ontario

Date: May 31, 2018 DRAFT REPORT

Project No. 218050

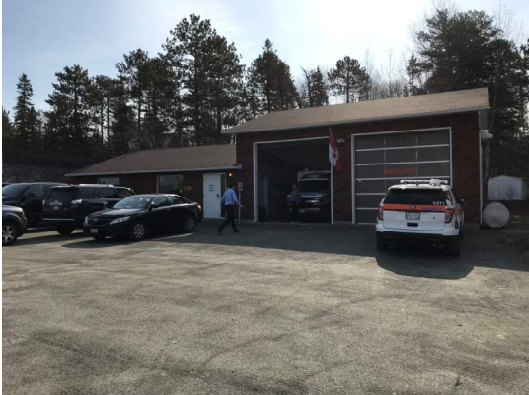
Photo 1 - Parking Lot Entrance

The parking area is located to the east of the building and is in FAIR condition with a rough aggregate finish which generally slopes away from the building to the road. There were no curbs or catch basins observed. No line painting was visible. Paving at the overhead door sills to the two ambulance bay was deteriorating/sunken away from the concrete curb. Asphalt is ramped up at the main entry door and still contains a step of approx. 3". There is no level area at the door and it is not flush with the door sill level so it is not barrier free accessible.

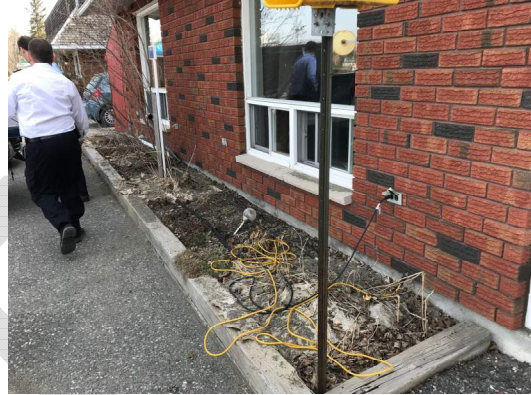
Photo 3 – Planting Bed

The planter bed located at the front of the office portion of the building was constructed from pressure treated 6x6 lumber raised above the level of the asphalt pavement surface, and appeared in GOOD condition.

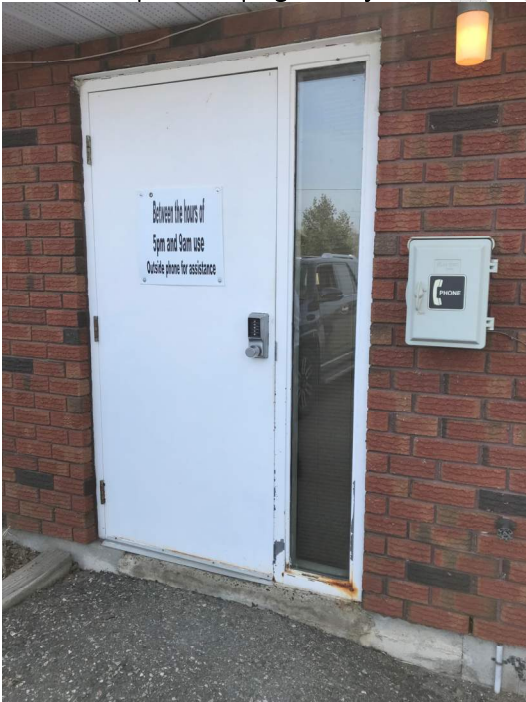
Photo 2 – Asphalt ramping at entry door

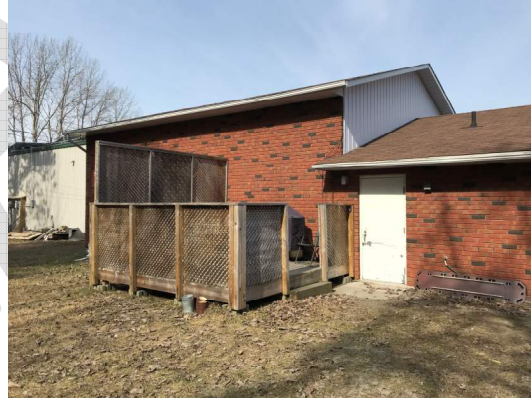
Only one small poured concrete pad was located at the rear exit door. The pad appeared in FAIR condition and was dropped approximately 2" below the door sill.

The wood deck is approximately 12'x12' and constructed from pressure treated lumber. Floor joists appear to be 2"x8" joist and is raised approx. 12 – 14" above grade. There is a single step, made from an 8x8, to the platform and privacy screens made from posts and rails with a tight privacy lattice. Deck boards were 2x6 and appeared to be in GOOD condition. This deck is mounted on precast concrete deck blocks that sit on grade, no settlement was obvious. It appears to be constructed within the last 5 years.

Photo 4 – Concrete Pad and Wood Deck

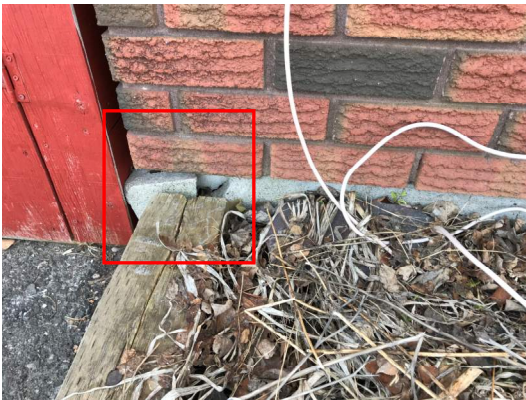
The owner provided the original drawing for the building which indicated 10" concrete block foundations on strip footings to an approx. depth of 80". The drawings show 2" of insulation on the inside of foundations down 4' and horizontally for 4' around the perimeter of the building. Block outline could be seen through parging. In three locations there was deterioration of a mostly isolated to a single block. One located at the north-west corner block is cracked at the corner, and three others the face of the block is deteriorated through the parging at the south east corner and the fourth location at the south west corner. At the north-west and south east locations, no obvious reason for the localized deterioration and it is isolated to a single block with no cracking observed in the brick above. At the south west corner step cracking was visible in the lower 2 feet of the brick on both sides of the corner potentially indicating some settlement.

Photo 7 – Foundation block cracked at N-W corner

- *Patch and repair two locations of damaged block at foundation recommended within the next year to eliminate potential of further deterioration.*
- *Engage a structural engineer to review the potential settlement issue at the south west corner.*

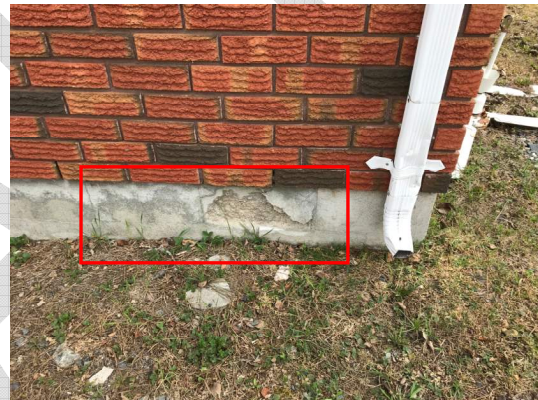
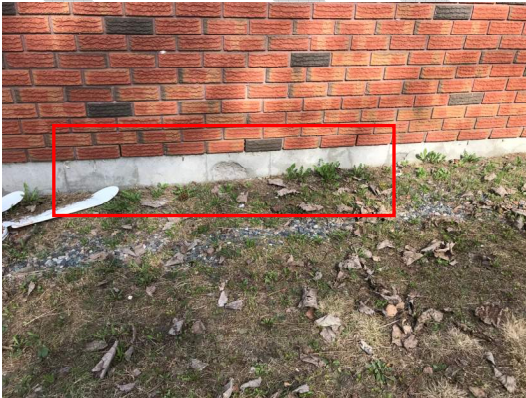
Foundation wall parging appears generally in FAIR to POOR condition some isolated locations where foundation deterioration was noted with hairline cracks at joints and deterioration at the above noted foundation damage.

Photo 9 – Spalling of parging and block S-E corner

Photo 8 – Spalling of parging and block S-E corner

Action: Watch for further deterioration/opening of cracks. Patch and repair parging, work may coincide with foundation repairs recommended in the next 2-3 years.

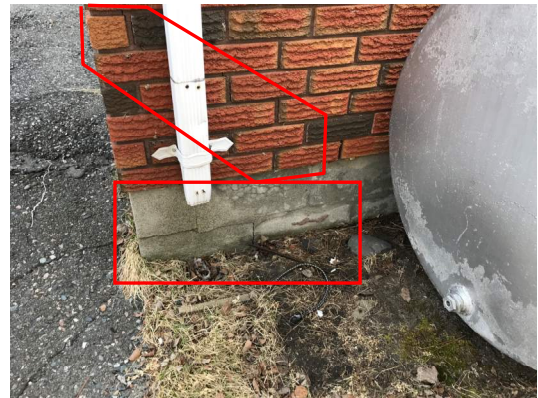
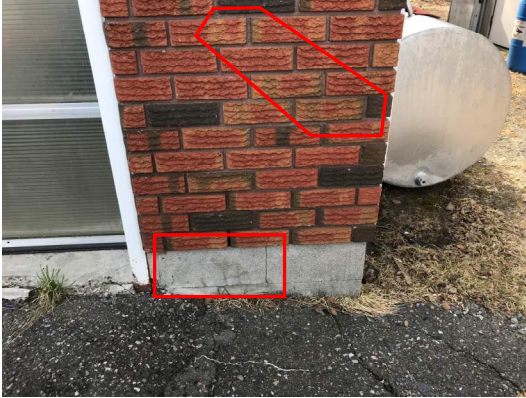
Mortar appeared generally sound with no obvious deterioration except at joints in precast concrete window sills and one isolated location at the south west corner of the ambulance bay (refer to foundation notes above).

Photo 10 – Step cracking in mortar joints at S-W corner

Photo 11 – Step cracking at SW corner

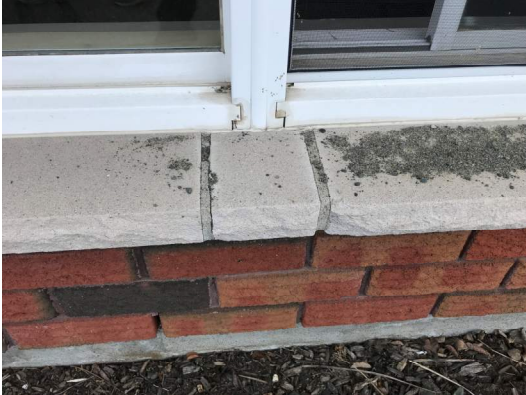
Typical windows sills were coped with precast concrete copings which appear to be in GOOD condition and sloped to drain away from the window. There were several joints within the span of a window and the mortar between was generally cracking.

Photo 12 – Cracked mortar at concrete copings

Action: Install insect baffles in vent holes. Repair mortar joints in precast sills or replace with one piece sills.

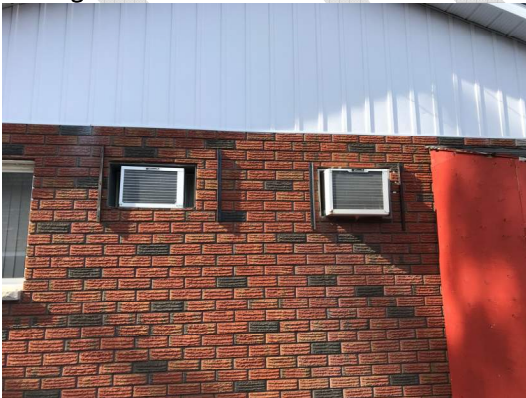
Prefinished vertical vinyl siding located on gable ends of roof trusses, appears to be original and in FAIR condition. Some chalking of vinyl was apparent. The bottom of the vinyl siding where it contacts brick does not have a drip flashing to shed water past the face of the brick below.

Photo 13 – Caulking of Vinyl and Drip trim missing

Action: Drip flashings should be installed when siding is replaced.

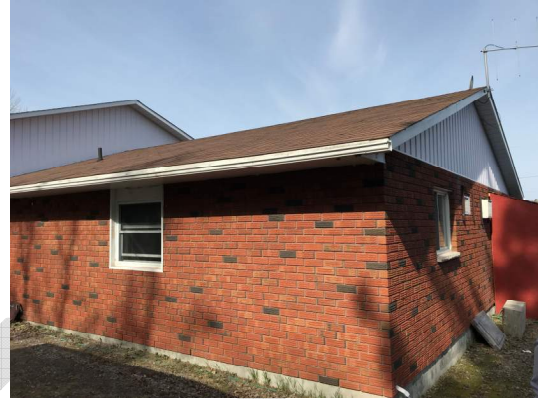
The asphalt shingle roofing was replaced approximately 5 years ago according to the owner. The roof is a relatively low slope roof. A drip edge starter strip does not appear to have been installed, and it is unclear if ice and water shield was installed at the eaves. No ridge venting or venting devices were installed for the peak of the roof. Based on the age of the roofing and no obvious curling the shingles appear to be in GOOD condition. Plumbing vent appear to be installed with proper boot. Shingles installed over base of satellite dish.

Flashing at low roof to wall appears to be missing. Vinyl siding extend right to shingle level. No leaks inside the building were reported.

Eavestroughs are seamless aluminum and appear in GOOD condition but downspouts have all been fallen off or sheared at the connection to the trough.

Photo 14 – No drip edge or venting of roofs.
No apparent metal flashing at vinyl siding to upper roof
Downspouts missing or disconnected.

Action: Repair of eavestroughs and downspouts will eliminate damage to grass and prevent splash up onto brick and foundation.

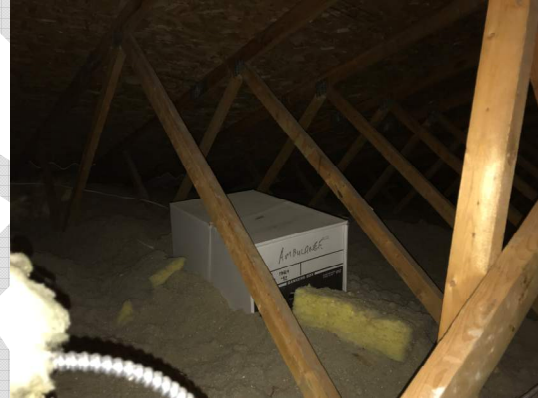
The attic over the office was accessed during the visit and it was observed to be wood framed roof trusses with plywood decking. The insulation was a mix of fiberglass batt and loose cellulose insulation of varying thicknesses and was somewhat disturbed in several locations. It appeared to be approximately 6" thick near the access hatch. Insulation baffles were observed at the eaves in every second truss space. The attic to the upper roof was inaccessible at the time of visit.

Photo 15 – Attic Insulation and Venting

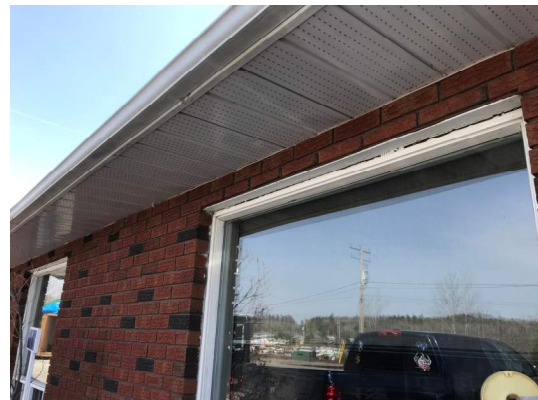
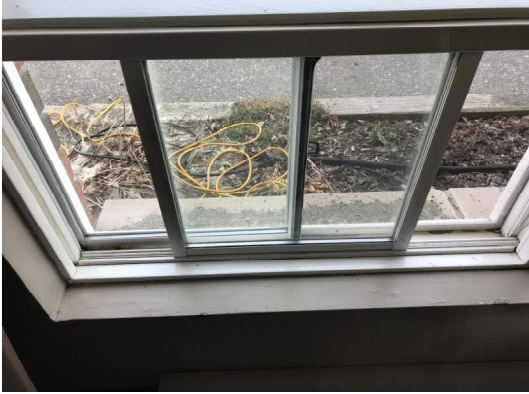
Windows are double glazed, combination of wood and vinyl, with a mix of fixed glazing and horizontal sliders which appear to be original to the building. Gaps in frames and poor seals at glazing to frames were observed. Users commented that water comes through windows in driving rains. Windows are in POOR condition and should be replaced.

Photo 16 – Wood/Vinyl windows in poor condition and sealant failure

Photo 17 – Window weather-stripping broken. Sealants have failed.

Action: Replace old vinyl and wood windows with new windows ASAP to reduce potential water infiltration inside the building. Consider low-e and argon filled for energy efficiency.

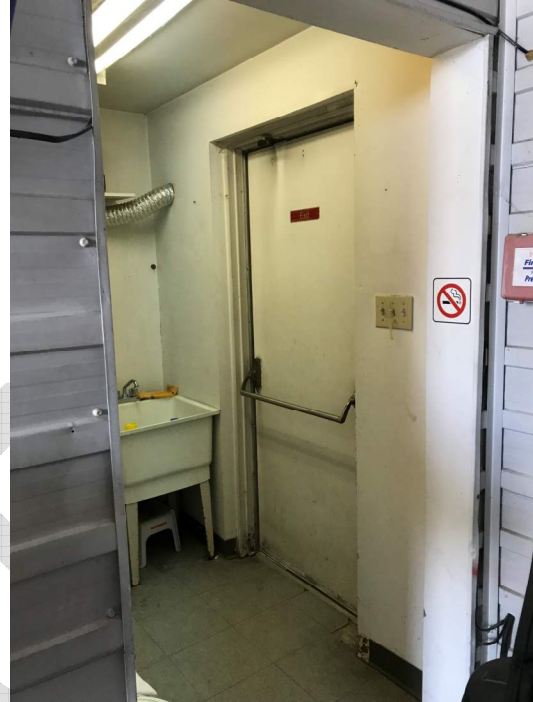
Exit service doors are of insulated hollow metal construction in pressed steel frames. The frame is not thermally broken. The doors appear to be original construction and are in FAIR condition, showing signs of light corrosion on frame at sill. Closer was removed. Weather stripping and threshold appeared in FAIR condition.

Photo 19 – Exit/service door rust and missing hardware

Action: Replace closer. Remove rust and repaint door and frame. Periodically review hardware for operation and wear, replace as needed (consider lever handles).

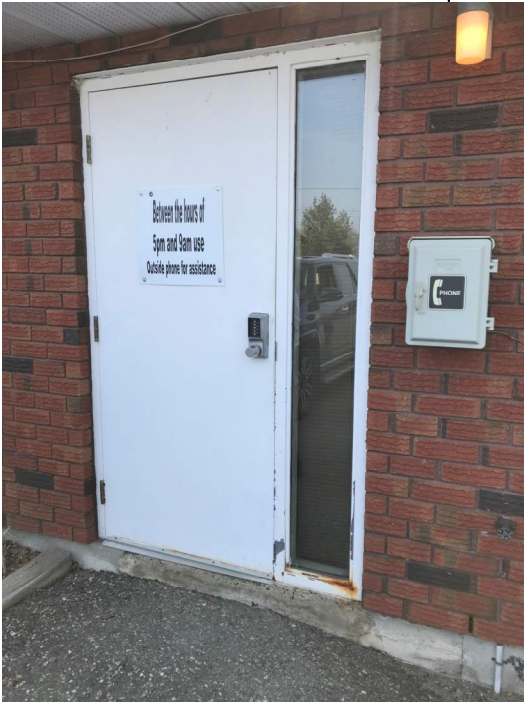
Exterior insulated hollow metal door with sidelite sealed glass unit were in FAIR to POOR condition. The paint finish is scratched and rusting at sill of jamb frames, door and sidelite. Door hardware was generally older but appeared in FAIR condition. Weather stripping and sweep was in POOR condition. The aluminum thresholds were not thermally broken, but were in FAIR condition. Door is combination keypad locked.

Photo 18 – Entrance Door rusting frame and Non barrier free accessible step.

Action: Replace failing weather stripping. Consider replacing door and hardware or remove rust and repaint.

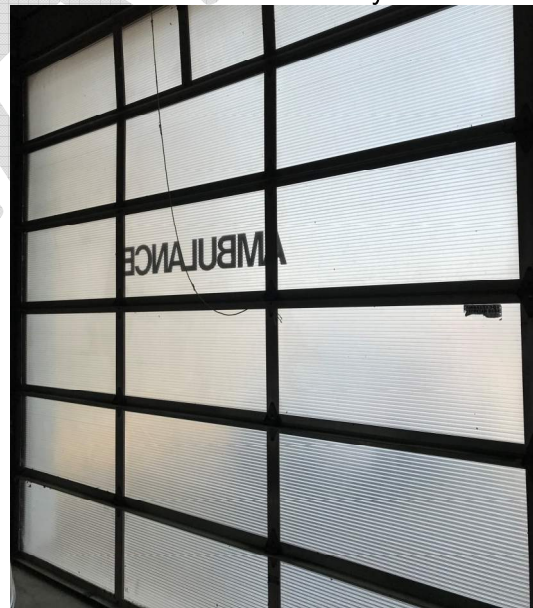
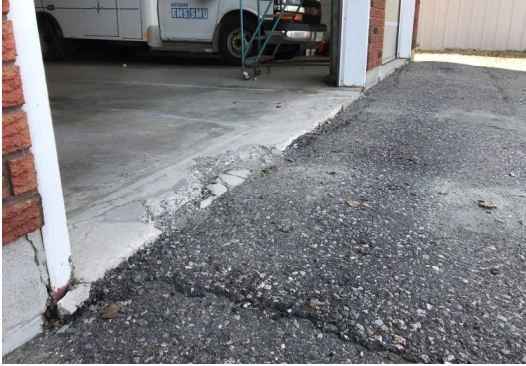
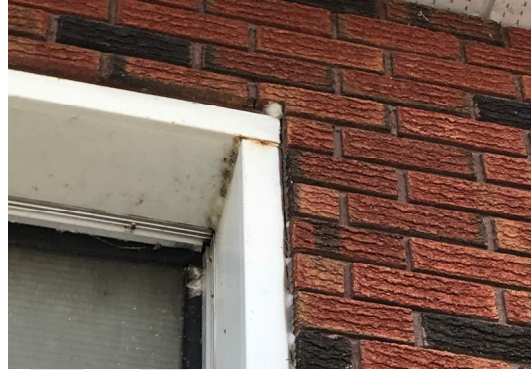
Two power operated exterior overhead doors were observed on the double ambulance garage bay. The doors are translucent plastic/vinyl/poly-carbon material. The weather seals appear to be in FAIR/POOR condition, but are starting to deteriorate at the sill and bottom edge of the jamb. The sill seal appears to have shrank. Staff did not complain about the operation of the doors, but indicated the doors are not thermally efficient.

Some rusting was observed at the bottom of the jamb frames on the bay doors and chips in the paint around the perimeter metal frame.

Poured concrete sills at overhead doors are cracked and spalled in several locations. Sill in POOR condition.

Photo 20 – O/H door not thermally insulated

Photo 21 – O/H door rusting frames and chipped sills/foundations

Photo 22 – O/H door lintel to be confirmed. Weather stripping and sealant deteriorating.

- *Replace weather seals*
- *Remove rust and repaint frames.*
- *Patch concrete sills/foundation.*
- *Consider replacing overhead doors with more energy efficient doors.*

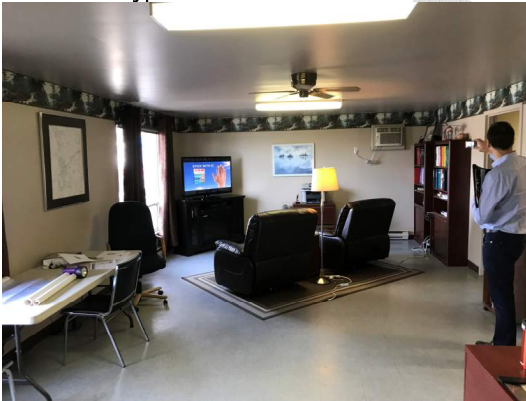
Photo 23 - Typical interior finishes.

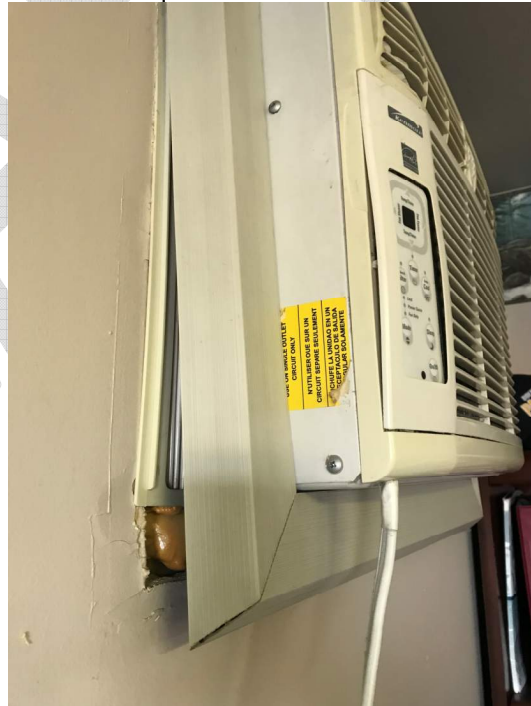
Photo 24 – Gaps at thru-wall A/C units

Action: Review with mechanical report comments, patch and repair openings as required to match existing assemblies.

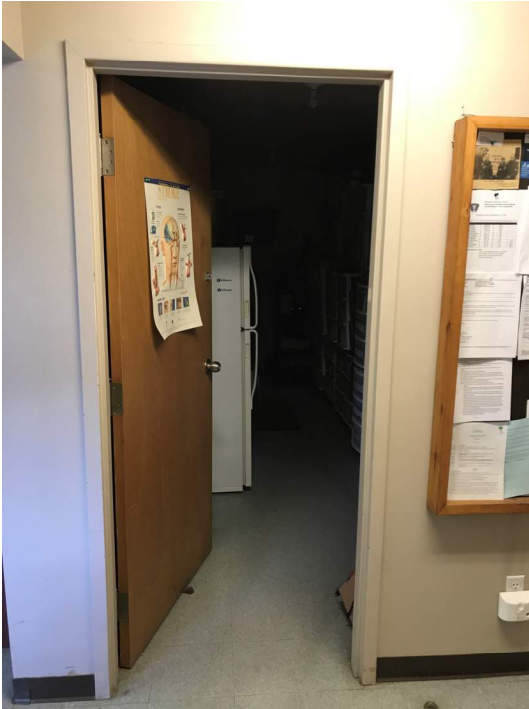
Interior doors are typically solid core wood doors in hollow metal frames. The doors are wood veneer and appear to be in FAIR to GOOD condition with minor scratches and nicks. Hollow metal frames are in generally GOOD condition with some nicks and scratches. Hardware appears original, so doors and frames are generally unmodified.

Residential grade door hardware was in use. Round knob style passage sets with push button lock and floor mounted door stops. Closers were not typically installed. Passage sets and hinges appear to be in generally FAIR condition, but may be approaching expected life cycle.

Photo 25 – Typical wood door with knob style hardware, chips in hollow metal frame paint finish.

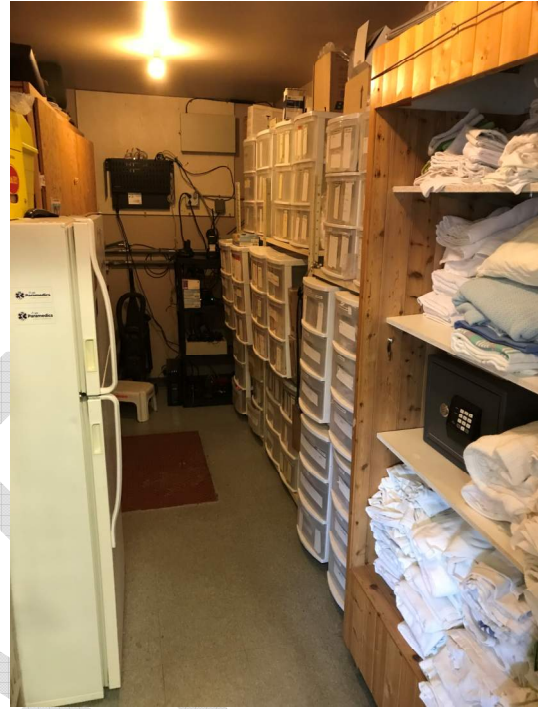
Medical supply storage was contained in plastic slide-out bins on a metal storage rack system. Units were tilting out of the storage units and should be fixed or replaced.

Photo 27 – Stores/equipment new racks and possibly reorganization required.

Actions: Review storage needs and potential to expand store/equipment space. Potential to relocate lockers and fridge. Recommended to be implemented at same time as fire separation repairs noted above.

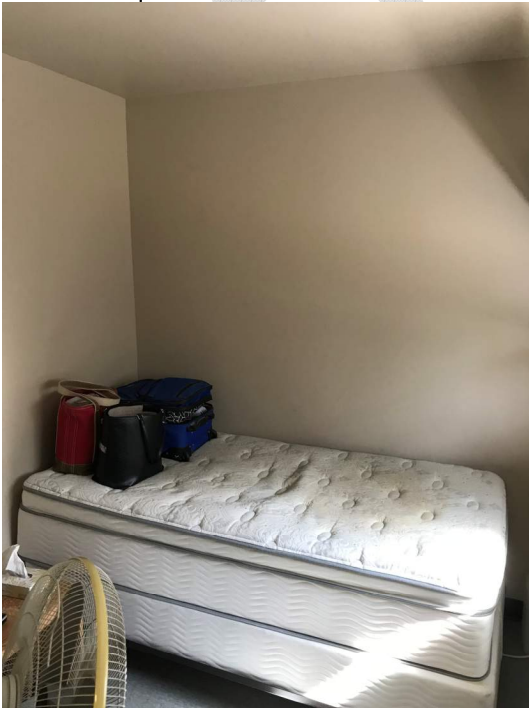
Typical interior walls are wood stud framed with gypsum wallboard each side and paint finished. The paint finish was in FAIR condition. Walls were typically original construction with the exception of the walls at the Bedroom which was renovated from janitors and storage closets, extending into the office space.

Photo 26 – Space renovated to a bedroom.

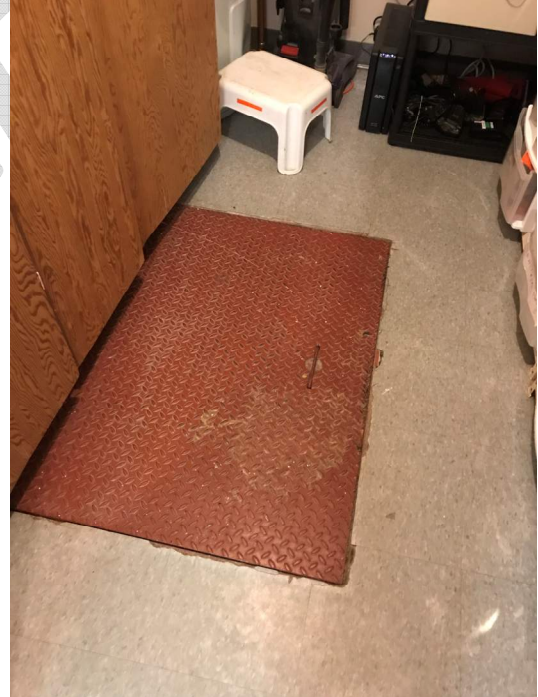
The floor construction is poured concrete slab on grade with VCT finish and rubber base. The VCT was showing signs of wear/chipping specifically edge of pump access door. VCT is in FAIR condition.

Photo 28 – Chips in flooring around hatch.

Action: Repair/replace damage VCT and base. Wax and reseal.

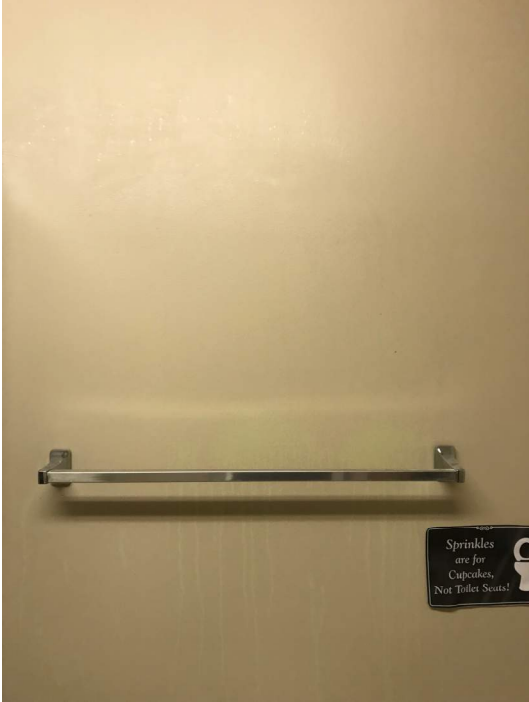
Same as typical, but some signs of moisture accumulation from shower with streaks in paint finish. Drywall does not appear to be blistering or sagging.

Photo 29 – Moisture streaks in paint in washrooms.

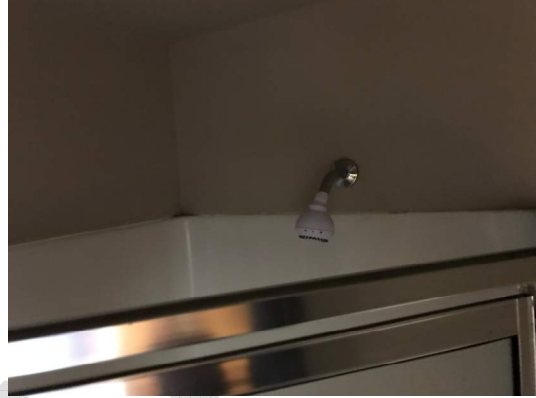
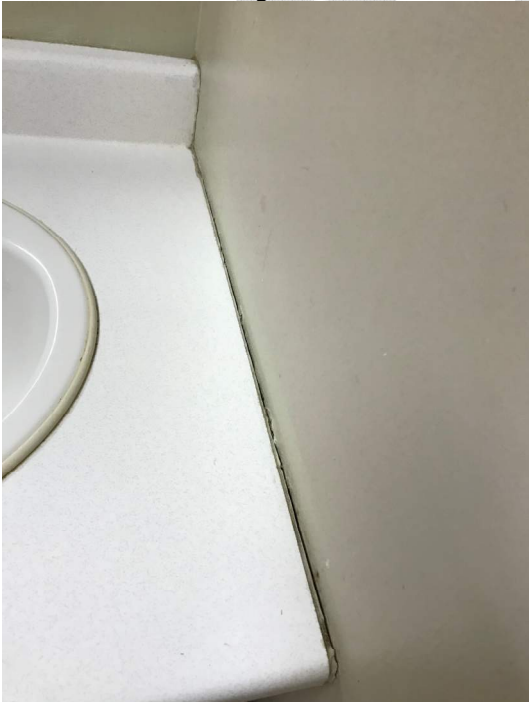
Photo 31 – Seals cracked at top of shower units

Photo 30 – Seals missing at washroom counters

Actions: Reseal at countertop. Watch for further deterioration of end trim. Refinish cabinet fronts.

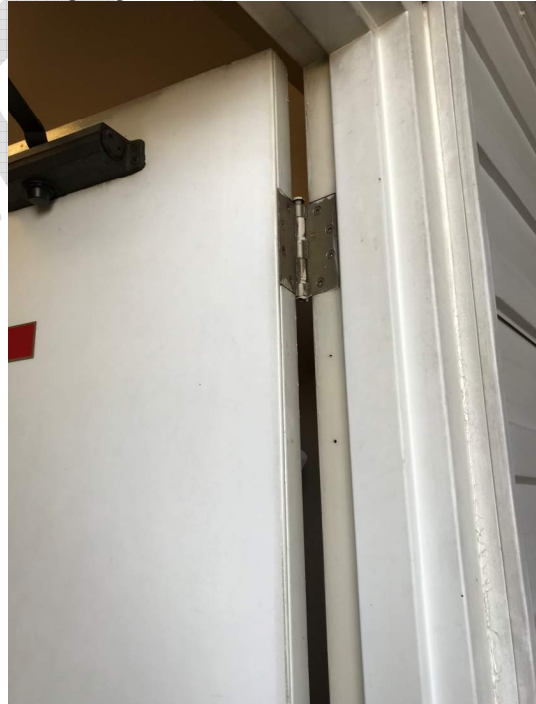
Photo 32 – Rating label missing on interior door from garage to vestibule

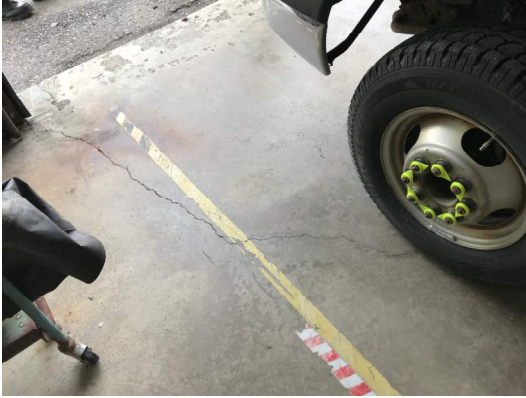
Photo 33 – Cracks in garage floor slab.

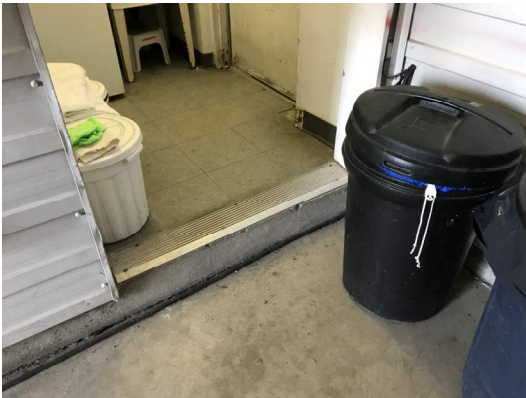
Photo 34 – Raised step to exit.
Seal at slab to base of interior wall

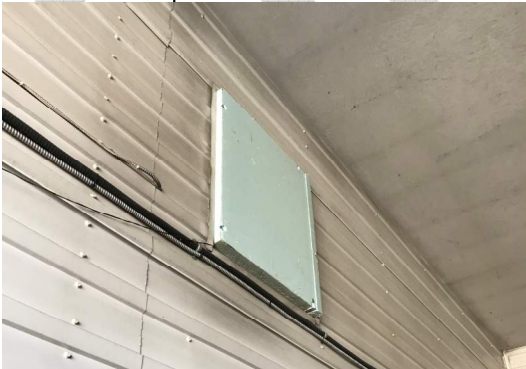
Photo 35 - Access panel not rated closure and covered with exposed foam insulation

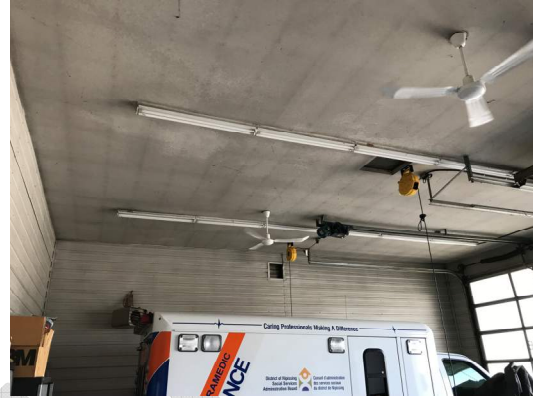
Photo 36 – Attic access hatch has no ladder access for upper roof. Confirm rated closure.

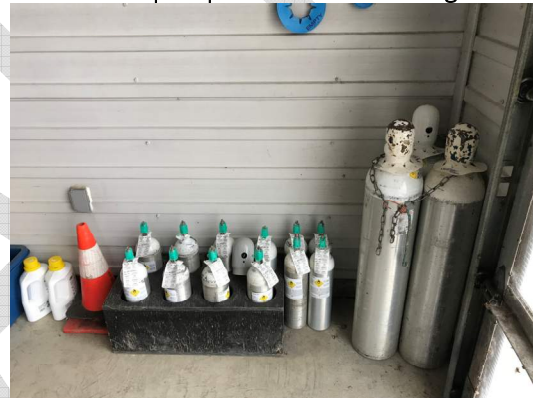
Photo 37 – Oxygen tank storage. Some tanks loose and require protection from damage.
