Sudbury, October 29, 2019

Your Ref.: 2019 Municipal Bridge Inspections  
Our Ref.: SUD-00019064-IS

**Subject: 2019 Municipal Bridge Inspections**

2019 OSIM FORM  
Bridge #001 – Wilson Lake Road Bridge No. 1

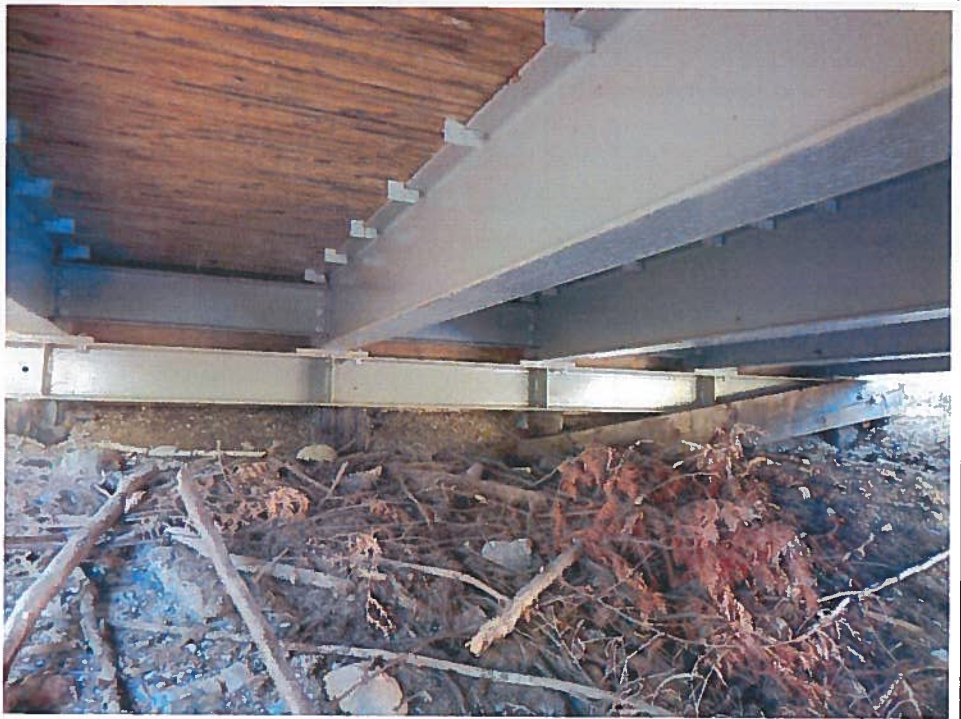
Superstructure and all pile caps are generally in good to excellent condition. Timber pile bent abutments and piers appear to be stable. No evidence of movement is observed.

Photo 4:  
Typical Abutment -  
South abutment  
shown.

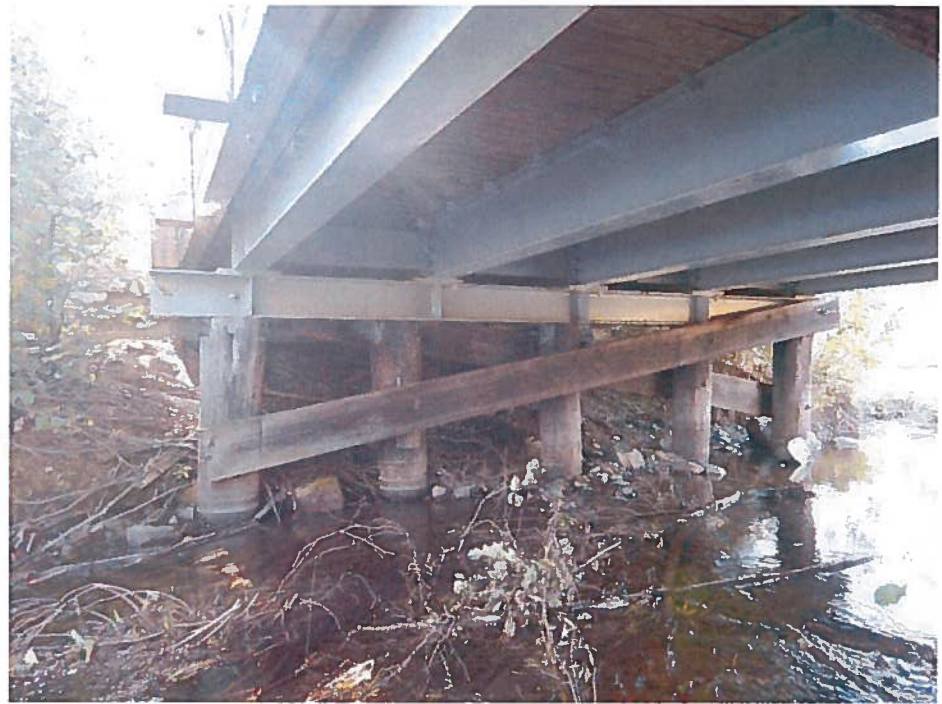
Photo 5:  
Typical Pile Bent  
Pier – south pier  
shown

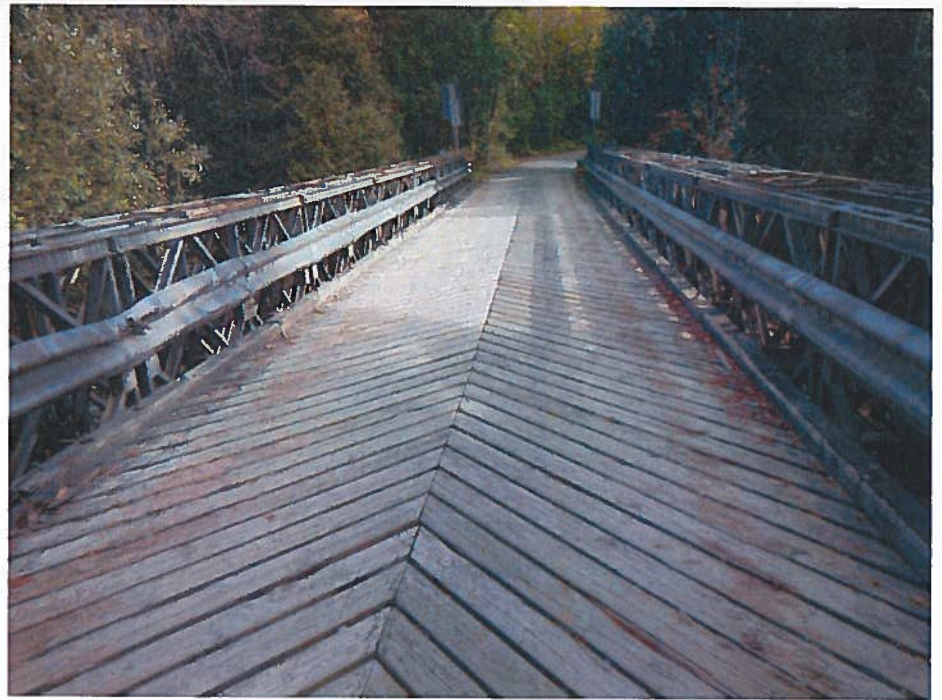
88.6	10	
<b>Comments:</b> timber curb at NW corner broken, generally fair to poor condition overall						
<b>Recommended Work:</b>		<input type="checkbox"/> Rehab <input type="checkbox"/> Replace		<b>Maintenance Needs:</b>		
		<input type="checkbox"/> 1-5 years <input type="checkbox"/> 6-10 years		<input type="checkbox"/> Urgent <input checked="" type="checkbox"/> 1 year <input type="checkbox"/> 2 year		
		replace timber curbs

Photo 2:  
Deck Looking South

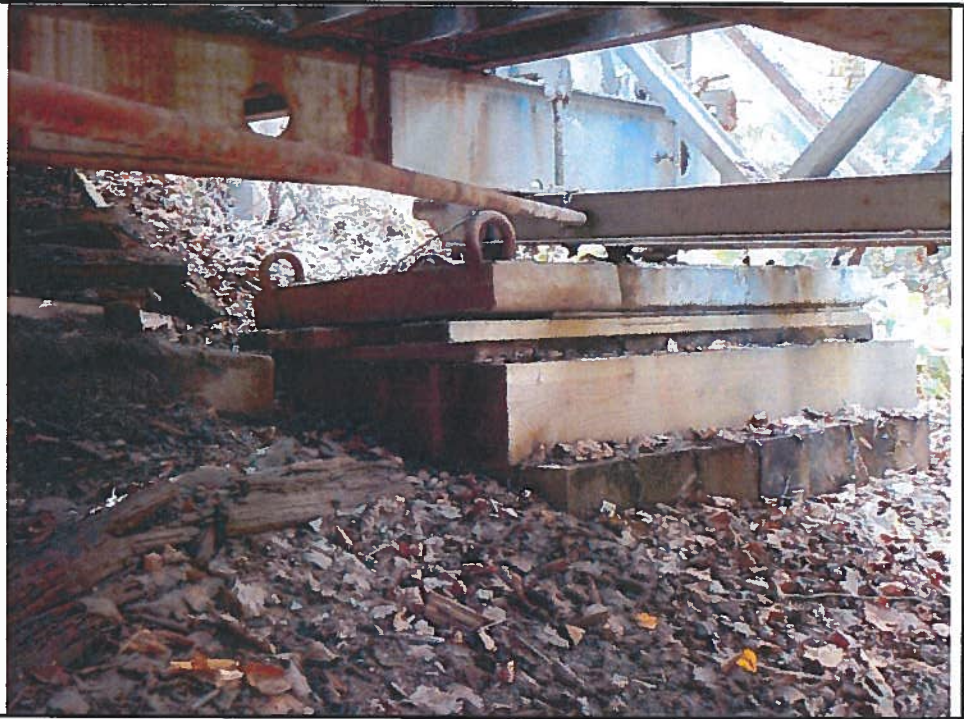
The bridge is generally in fair to good condition. Severe deteriorations were observed on timber curbs and approach guide rail timber posts. Minor settlements/movements were observed at three of the four bearing pads. We would recommend monitoring the settlements at all four (4) corners of the bridge where bearing pads are found.

Photo 5:  
Settlement at SW  
Bearing (Similar SE  
and NE Bearing)

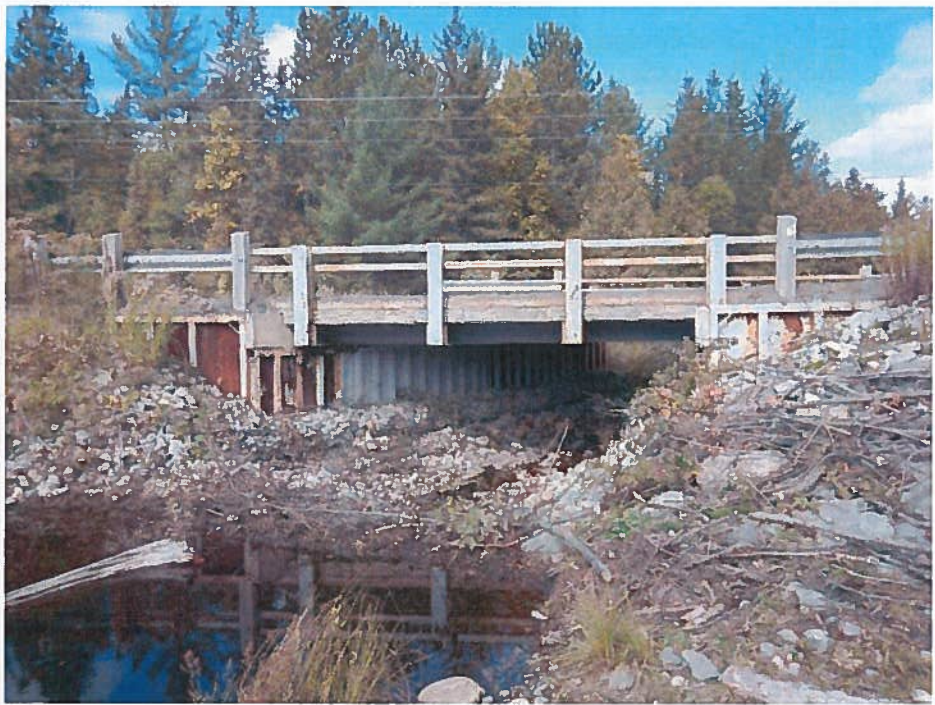
Photo 2:  
South Elevation  
(Upstream, note  
beaver dam)

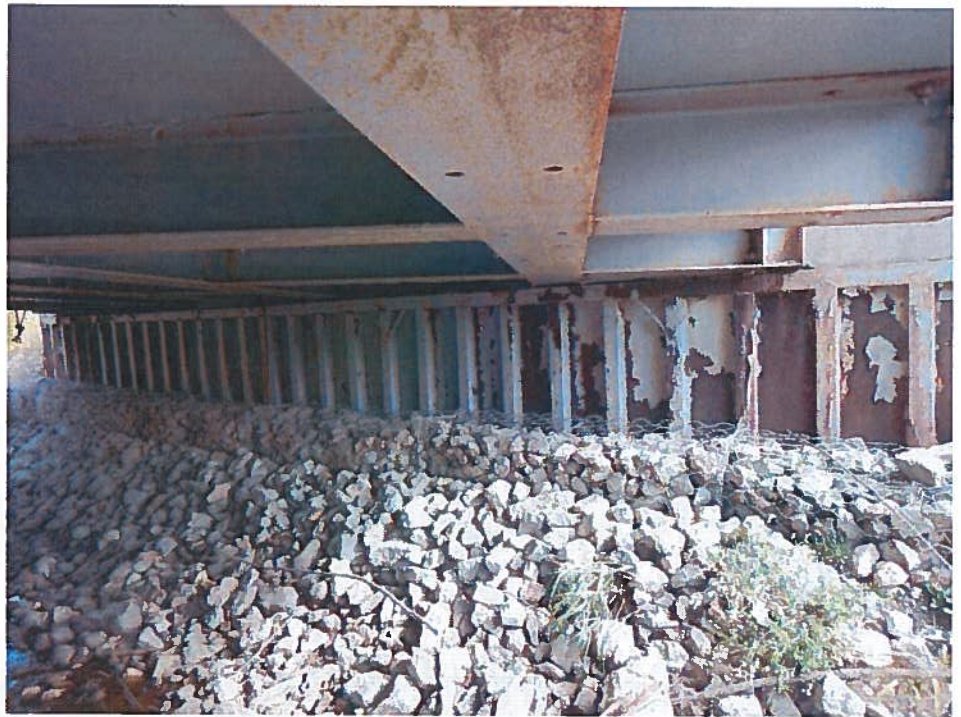
Photo 3:  
Abutment Wall –  
East abutment  
shown, West  
abutment similar

<b>Element Group:</b>	Abutment	<b>Length:</b>	2.15m
<b>Element Name:</b>	Wingwall	<b>Width:</b>	n/a
<b>Location:</b>	NE, NW, SE, SW	<b>Height:</b>	0.9m avg
<b>Material:</b>	Steel	<b>Count:</b>	4
<b>Element Type:</b>	Steel Panel	<b>Total Quantity:</b>	7.8 m2
<b>Environment:</b>	Benign	<b>Limited Inspection</b>	<input type="checkbox"/>
<b>Protection System:</b>	steel coating		
<b>Condition Data:</b>	<b>Units</b> m2	<b>Exc.</b>	<b>Good</b> 4.8
		<b>Fair</b> 3	<b>Poor*</b>
			<b>Perform. Deficiencies</b> 00
<b>Comments:</b> Steel Coating peeling.			
<b>Recommended Work:</b>		<input type="checkbox"/> Rehab <input type="checkbox"/> Replace	<b>Maintenance Needs:</b> 04
		<input type="checkbox"/> 1-5 years <input type="checkbox"/> 6-10 years	<input type="checkbox"/> Urgent <input type="checkbox"/> 1 year <input checked="" type="checkbox"/> 2 year
		re-coat wingwall panels

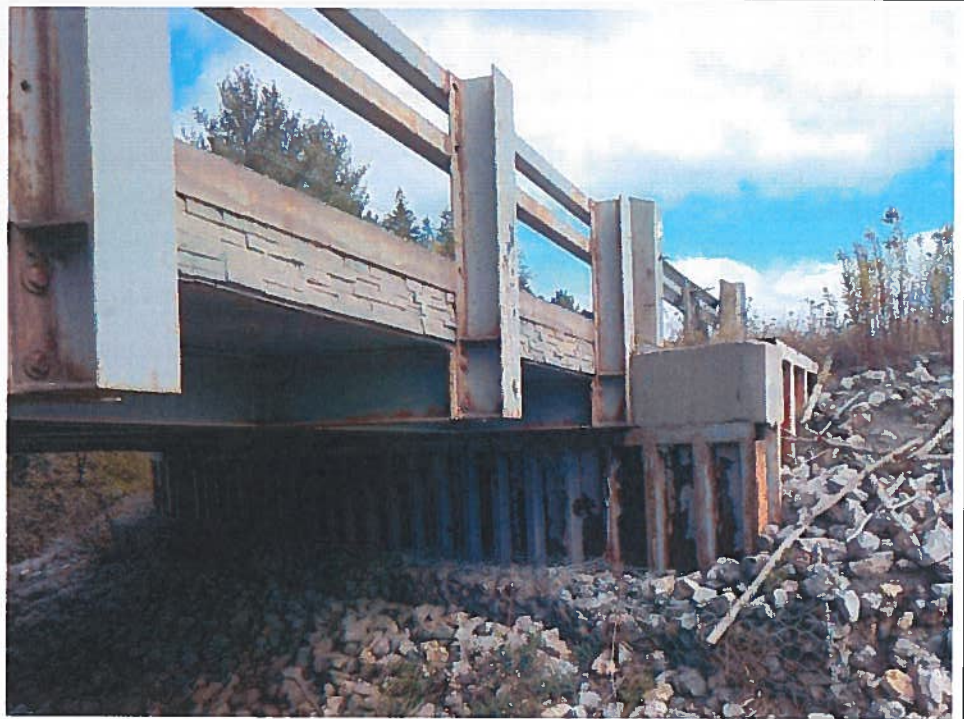
The bridge is general in good condition. Light to medium corrosion were observed at some of the girder ends. Coating on the abutment and wingwall steel panels were heavily deteriorating. Area of severe corrosion on base metal were observed. We would recommend the Municipality considering re-coating the steel components of the bridge. In addition, one identified broken timber guide rail post should also be replaced.

Photo 4:  
SE Corner of Bridge  
– note wide crack in  
concrete ballast wall  
and broken  
approach guide rail  
post.

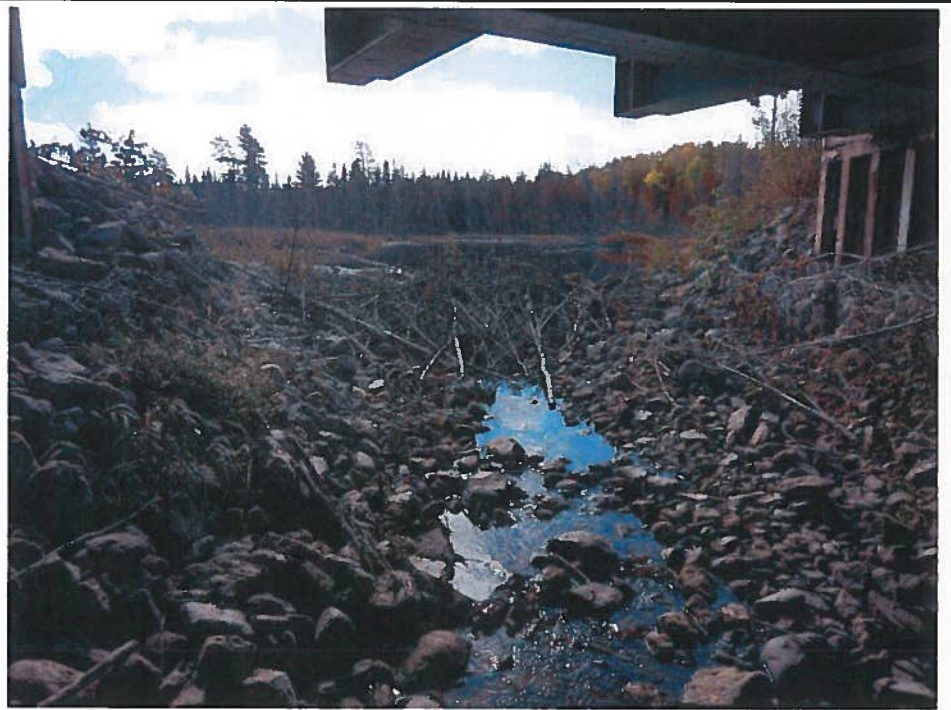
Photo 6:  
Channel Looking  
Upstream – note  
beaver dam
