Re: **LMS Job #LM19081**  
**Remotely Operated Vehicle Inspection & Report (ROV) – Temagami North Standpipe (SP)**

## WELDED STEEL STANDPIPE INSPECTION REPORT

Re: **LMS Job #LM19081**  
**Remotely Operated Vehicle Inspection & Report (ROV) – Temagami North Standpipe (SP) –**  
**Protective Coatings & Linings Report**

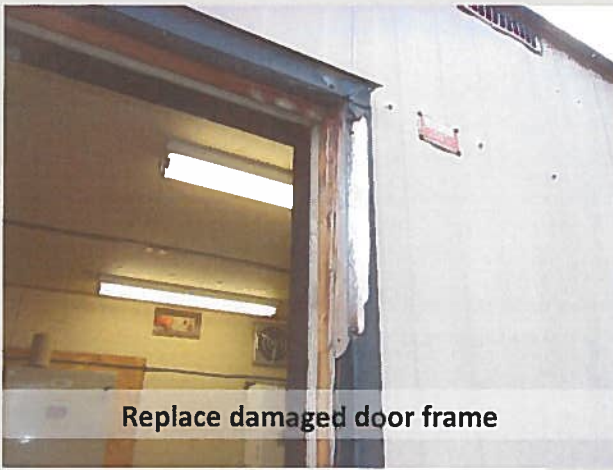
9

Replace damaged door frame

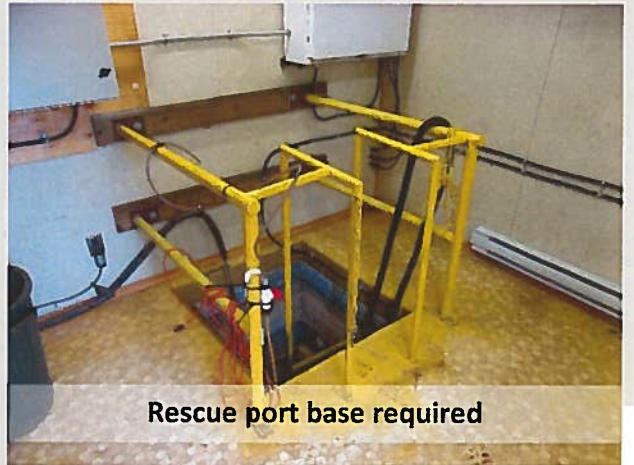
12

Rescue port base required

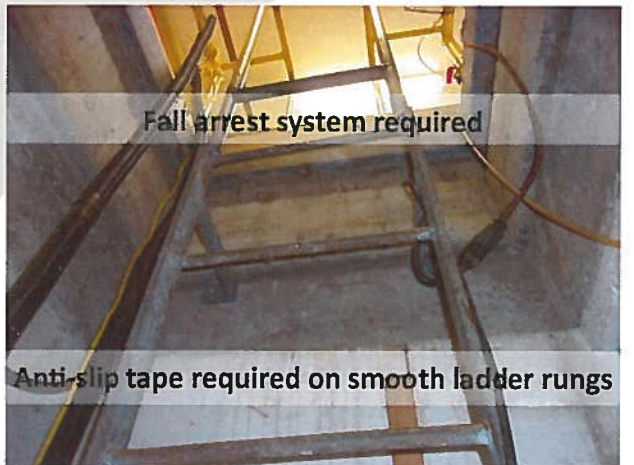
14

Fall arrest system required

Anti-slip tape required on smooth ladder rungs

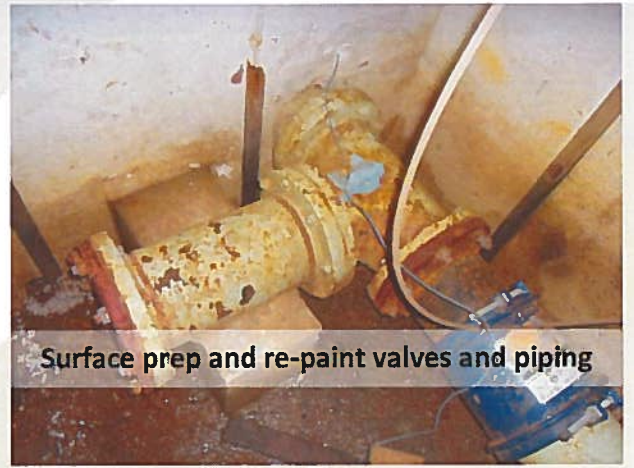
CONDITION OF VALVE CHAMBER / PIT	Fair - Minor damage to insulation in pit	24 - 25
CONDITION OF PIPING	Moderate surface corrosion	18 - 23
CONDITION OF VALVES	Moderate surface corrosion	18 - 23
ARE THERE ANY INDICATIONS OF SETTLEMENT (Exterior)?	No	18 - 23
IS THE CONCRETE IN THE CHAMBER CRACKED, SPALLED OR LEAKING?	No	18 - 23
IS THERE ANY INDICATION OF PIPE MOVEMENT?	No	18 - 23

Surface prep and re-paint valves and piping

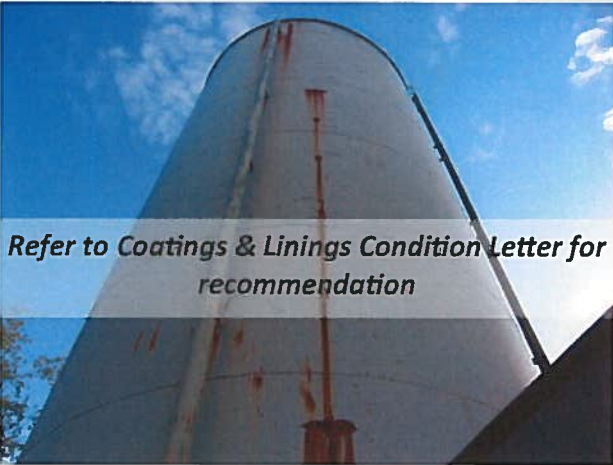
27

CONDITION OF SHELL PLATE	Structurally - Good; Coatings - Poor	26 - 32
ROOF CONDITION	Structurally - Good; Coatings - Poor	92 - 115
FLOOR PLATE CONDITION	N/I due to sediment accumulation	133 - 143

*Refer to Coatings & Linings Condition Letter for recommendation*

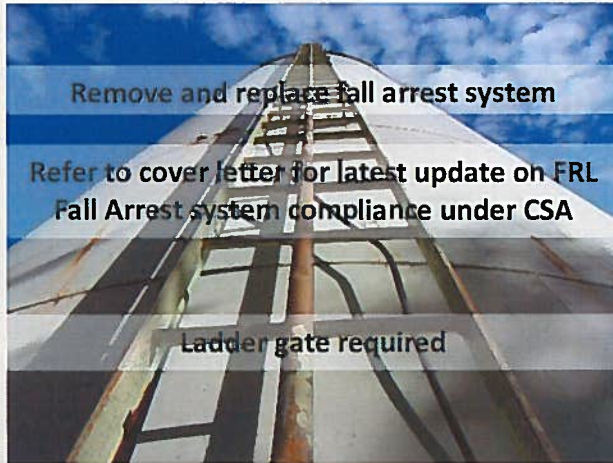
51

**Remove and replace fall arrest system**

**Refer to cover letter for latest update on FRL  
Fall Arrest system compliance under CSA**

**Ladder gate required**

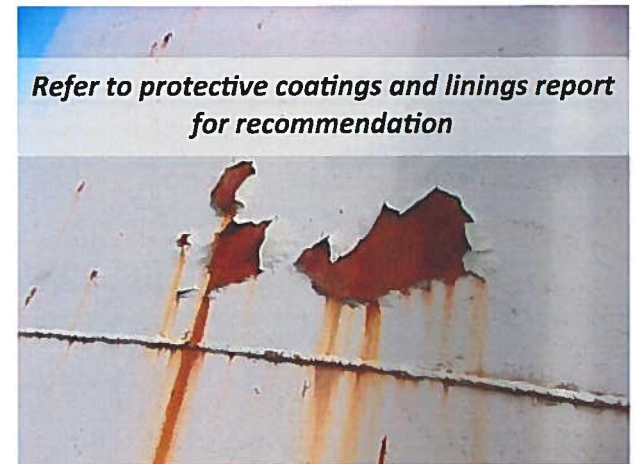
56

**Refer to protective coatings and linings report  
for recommendation**

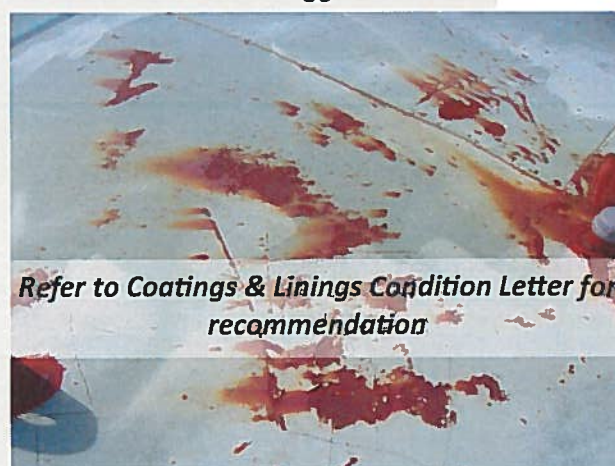
87

Refer to Coatings & Linings Condition Letter for recommendation

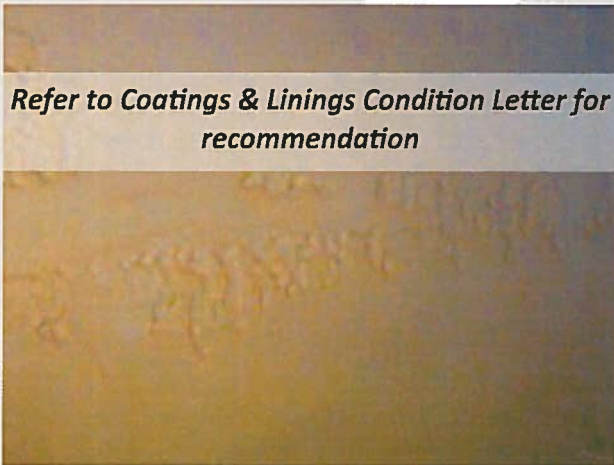
123

*Refer to Coatings & Linings Condition Letter for recommendation*

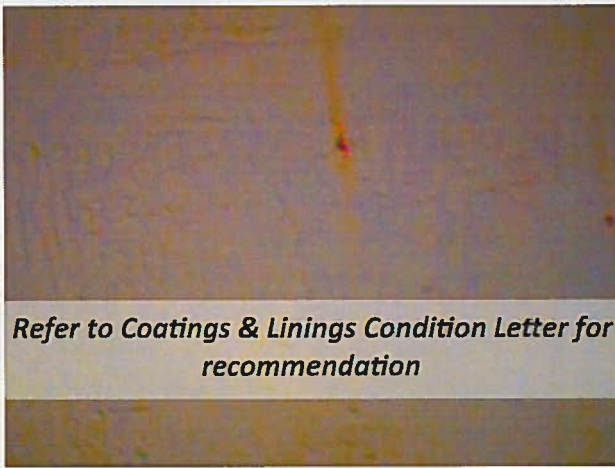
129

*Refer to Coatings & Linings Condition Letter for recommendation*

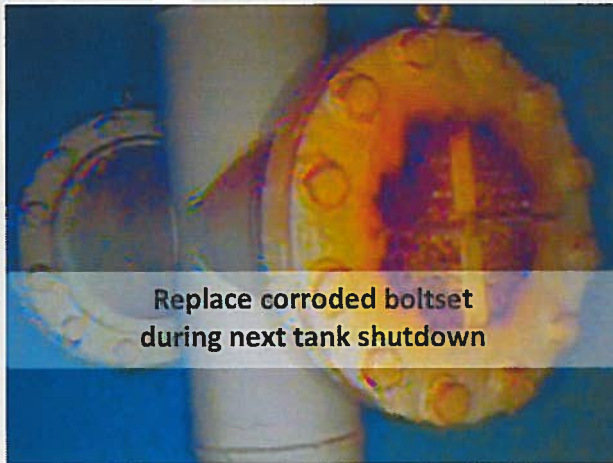
149

* Anchorage / Mounting	Fair	73 - 74
<b>CHLORINE ANALYSIS / DEAD ZONE TESTING</b>		Recommended	--
<b>MIXING SYSTEM</b>		Hydrodynamic system present. 2 stand-off brackets are damaged; corroded hardware should be replaced during next shutdown	148 - 154

Replace corroded boltset  
during next tank shutdown

| 22) Replace corroded bolt sets on mixing system | <b>\$ 1,400</b> |

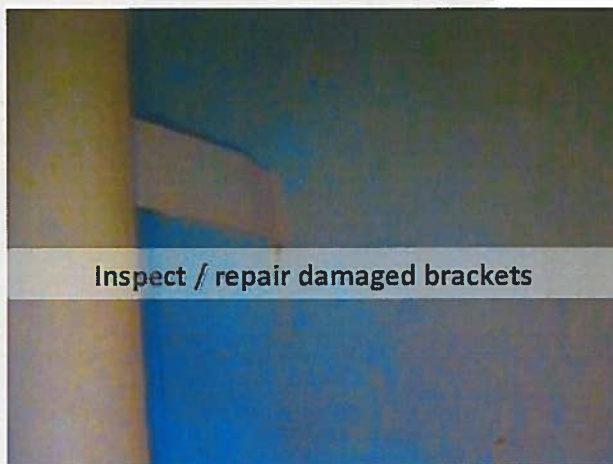
151

Inspect / repair damaged brackets

| 23) Inspect / repair damaged mixing system brackets (2pc) | <b>\$ 2,000</b> |

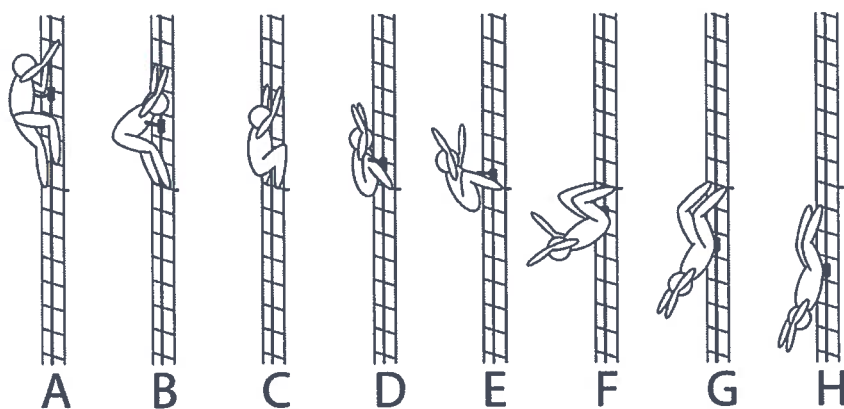
Figure 1: How the water tower worker fell

The investigation revealed a weakness in the design of some Class FRL Fall Protection Systems, which may not adequately protect workers who fall backward or who squat and roll backwards into a fall while connected by a body harness to the trolley which slides along the vertical rail. If a worker leans back, the trolley's internal braking system can be pulled off the rail, allowing the trolley to slide down the rail. If a worker falls backward or squats and rolls backward into a fall (as opposed to falling straight down or inwards towards the ladder) the trolley may not lock, allowing a worker to fall freely. In the 2014 incident, the worker fell from a water tower ladder as shown in Figure 1.

- A. The worker is descending properly using the fall protection system.
- B. The worker bends at the waist.
- C. The worker's legs fold into a squat position while the worker's hands catch the next rung. The squat position allows the trolley to travel below the height of the worker's knees.

Employers who own or rent structures which have a Class FRL Fall Protection System installed must ensure that the Class FRL Fall Protection System is capable of protecting a worker in the case of a squatting position/rollback fall or a fall backwards. The Ministry recommends that employers contact the manufacturer to ensure that the particular Class FRL Fall Protection System is capable of protecting a worker from any type of fall (including a backward fall and falling from a squatting position) before it is used.
