MUNICIPALITY OF TEMAGAMI

2023 Bridge Inspection Report

Project #23-0658
August 2023

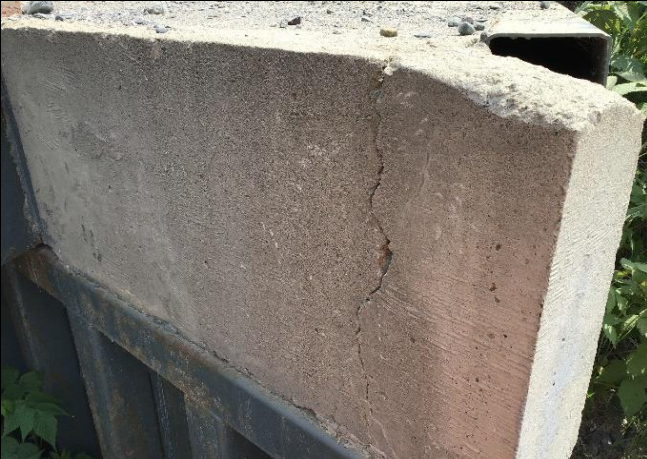
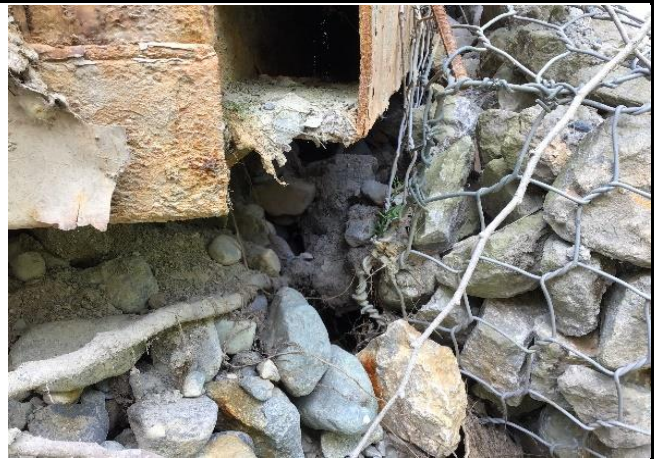
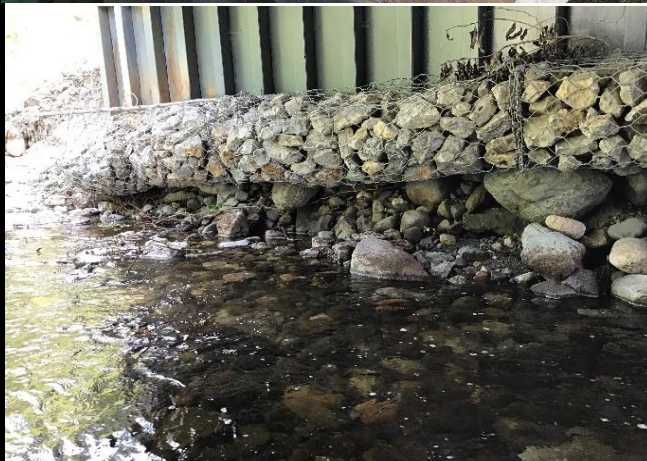
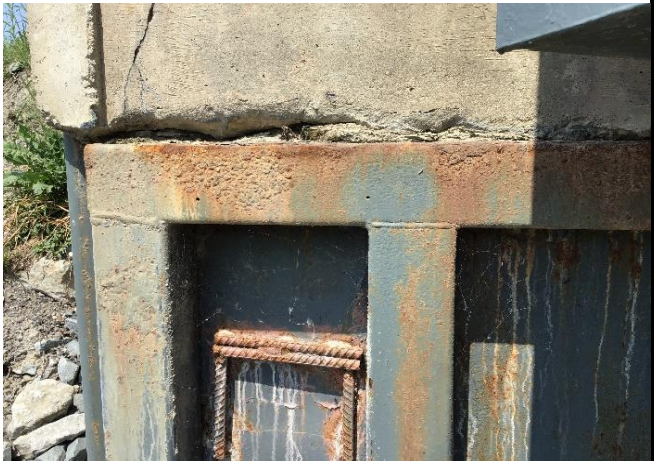
Lake Temagami Access Road Bridge has moderate erosion occurring underneath the east abutment wall. It is our recommendation that this be addressed and repaired within one year.

Recommended Work:	<input type="checkbox"/> Minor Rehab	<input checked="" type="checkbox"/> Major Rehab	Maintenance Needs:		
	<input type="checkbox"/> Replace	<input type="checkbox"/> None	<input type="checkbox"/> Urgent	<input type="checkbox"/> 1 Year	<input type="checkbox"/> 2 Year
Timeframe:	<input type="checkbox"/> Urgent	<input checked="" type="checkbox"/> 1 - 5 Years	<input type="checkbox"/> 6 - 10 Years		
Comments: Repair the undermining of the east abutment wall.
