**Lake Temagami Access Road Improvement Study, 2017 – Project No. NWL-01701027**

## Lake Temagami Access Road Improvement Study, 2017

# **IMPROVEMENT STUDY**

## **Lake Temagami Access Road, 2017**

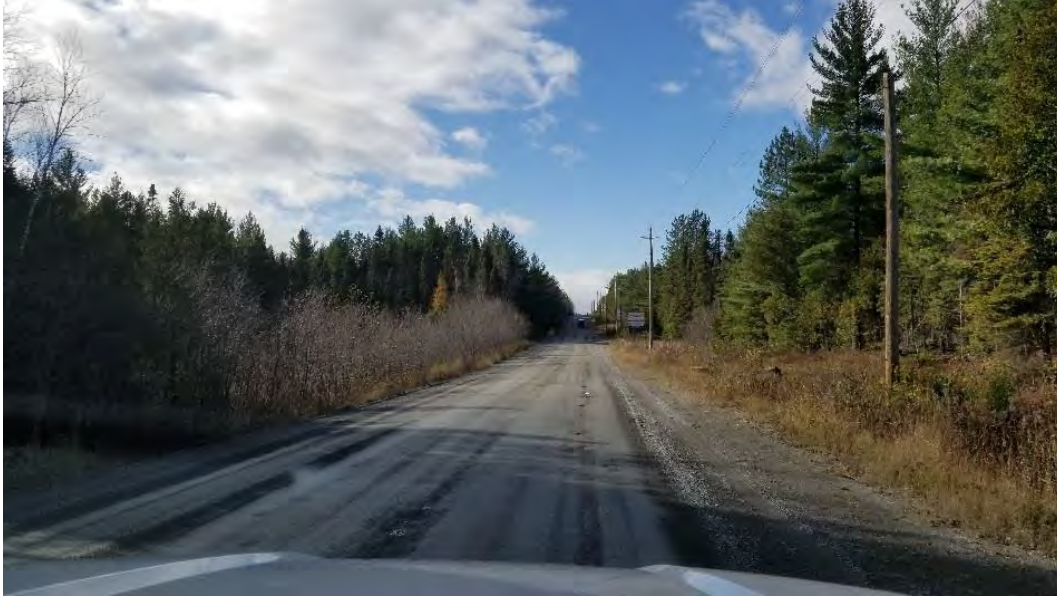
Picture 1 – Distress Area #1 (North on Right)

- 1.75 to 1.85 km
- Swampy area on both sides, road grade approximately 0.3m above water level.
- Roadway is wet, with shallow ruts and heavy potholing.
- Shoulders are very soft.

Distress Areas identified in **Section 5.2**, on the Lake Temagami Access Road, appear to be deteriorating due to excess water in the road base.

- Inadequate subsurface drainage, due to a lack of ditches or presence of rock obstructing existing ditches.
  - Rock excavation to establish positive drainage of both the subgrade and ditches.
    - Applies to Distress Area #5.
  - Granular A backfill to increase roadway crossfall and installation of subdrains.
    - Applies to Distress Area #10
- Differential water levels from one side of the road to the other.
  - Install or replace equalization culvert.
    - Applies to Distress Areas #3, 4, and 9
- Minimal grade separation between the water table and the road surface.
  - Grade raise using either select subgrade material (SSM) or rock fill as appropriate.
    - Applies to Distress Areas #1, 2, 3, 4, 6, 7, 8, and 9.

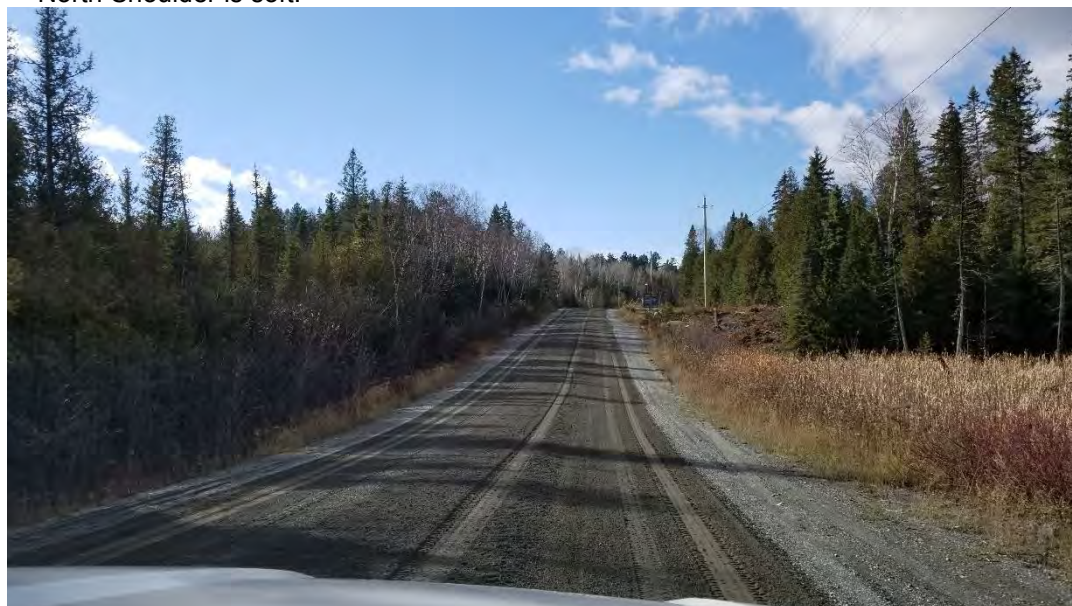
Picture 2 – Distress Area #2 (North on Right)

- 3.25 to 3.35 km
- Swampy area on North side, marshy area on South side.
- Roadway is wet, soft and heavy potholing.
- North Shoulder is soft.

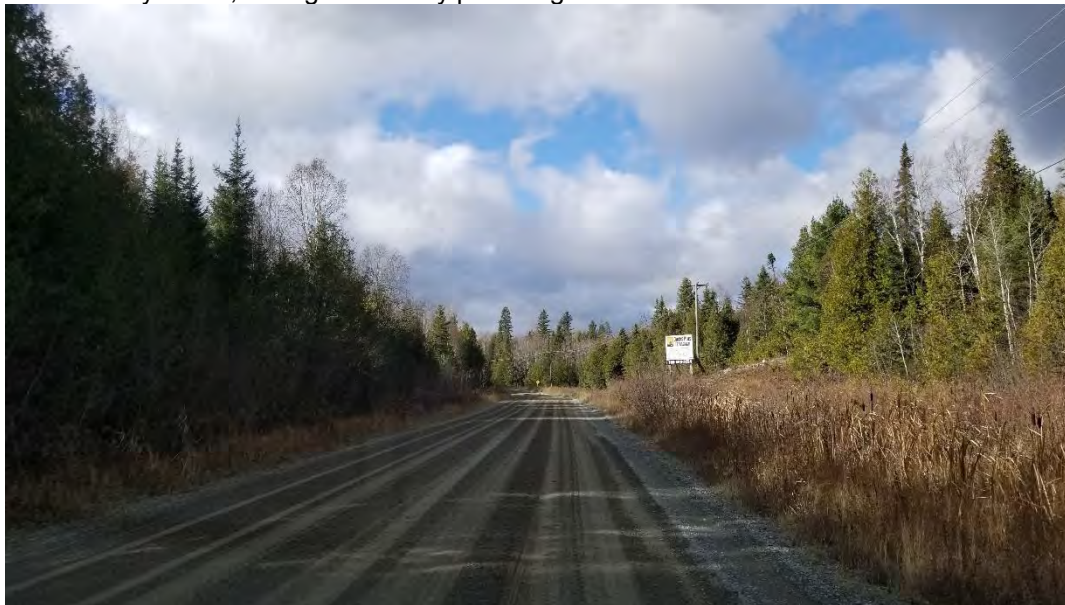
Picture 3 – Distress Area #3 (North on Right)

- 4.15 to 4.25 km
- Low point, ditches on both sides holding water.
- Culvert #9 in poor condition, heaved above bottom of ditch, collapsing.
- Roadway is wet, rutting and heavy potholing.

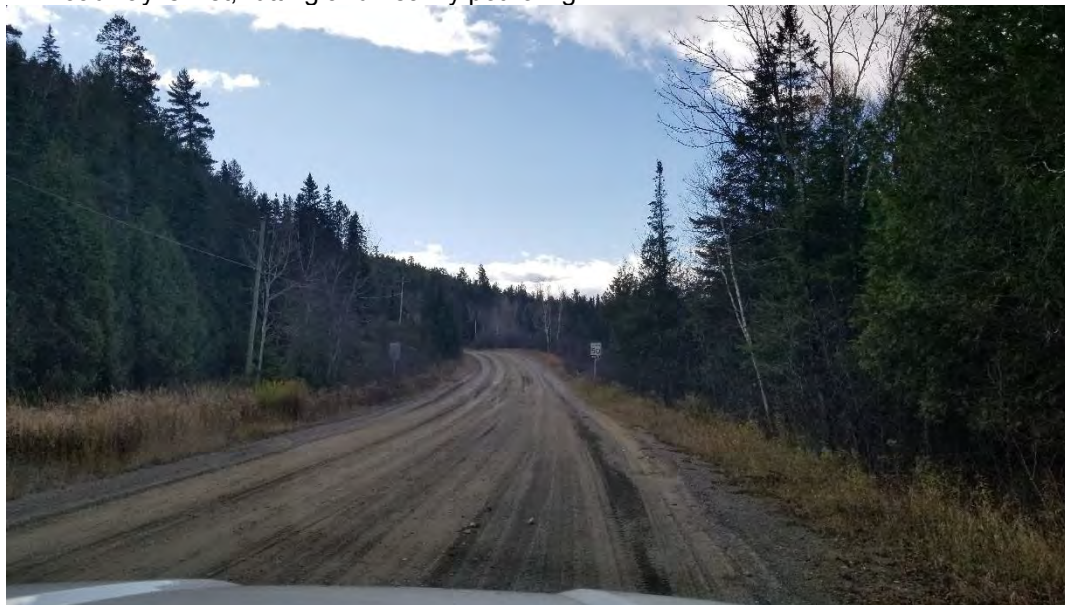
Picture 4 – Distress Area #4 (North on Right)

- 6.6 to 6.7 km
- Pond on North side, marshy area on South side, road grade approximately 0.3m above water level.
- Culvert #16 flowing to the South in poor condition, collapsing, and heaved.
- Roadway is wet, rutting and heavily potholing.

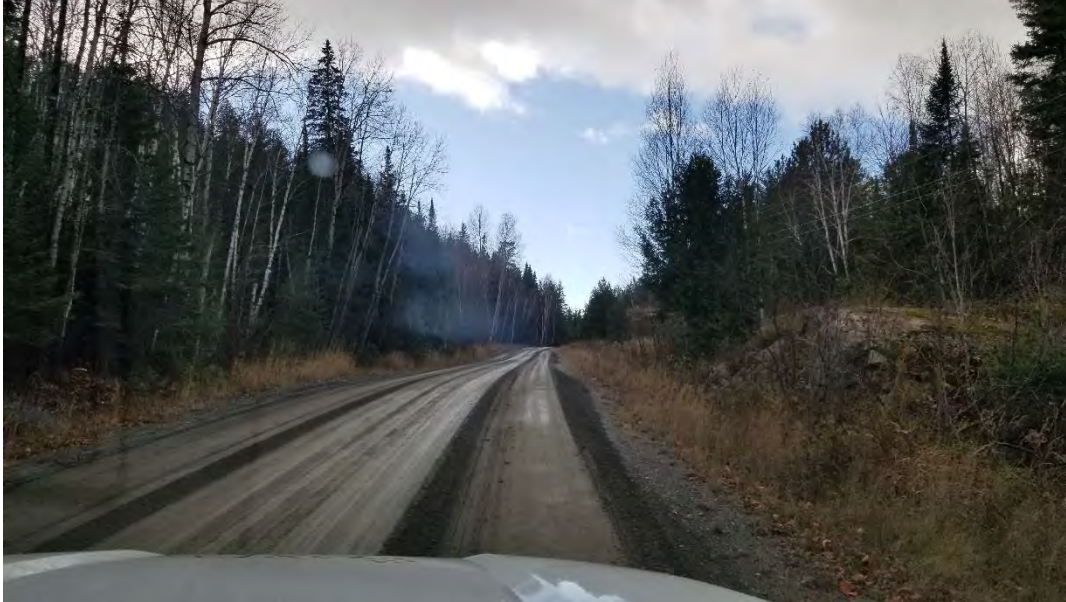
Picture 5 – Distress Area #5 (North on Right)

- 7.85 to 7.95 km
- Rock cut on both sides, minimal or non-existent ditches.
- Roadway is wet, rutting and potholing.

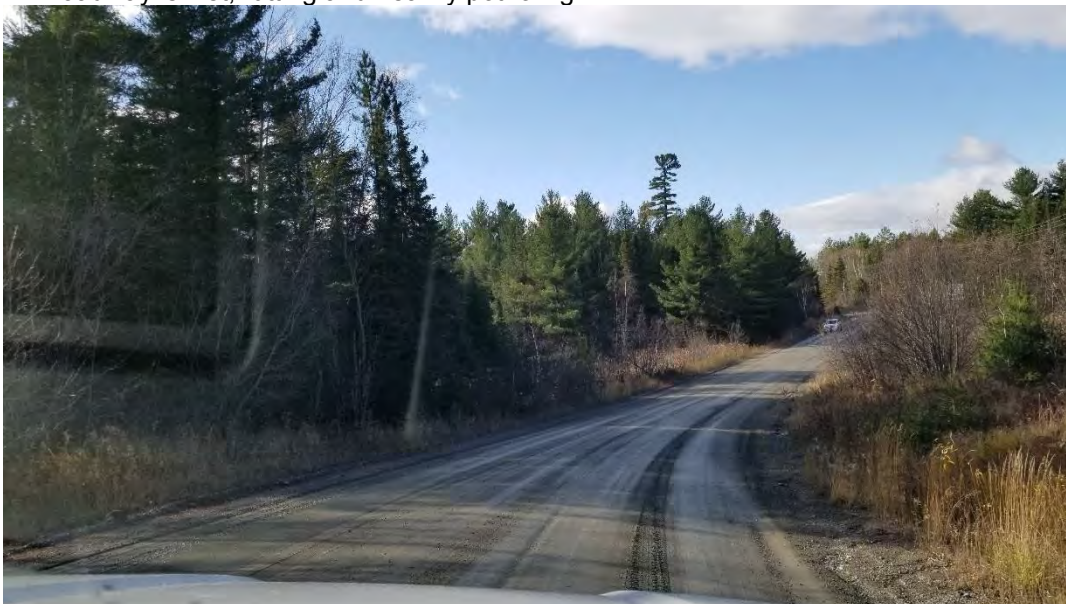
Picture 6 – Distress Area #6 (North on Right)

- 9.65 to 9.75 km
- Swampy area on both sides, road grade approximately 0.2m above water level.
- Roadway is wet, rutting and heavily potholing.

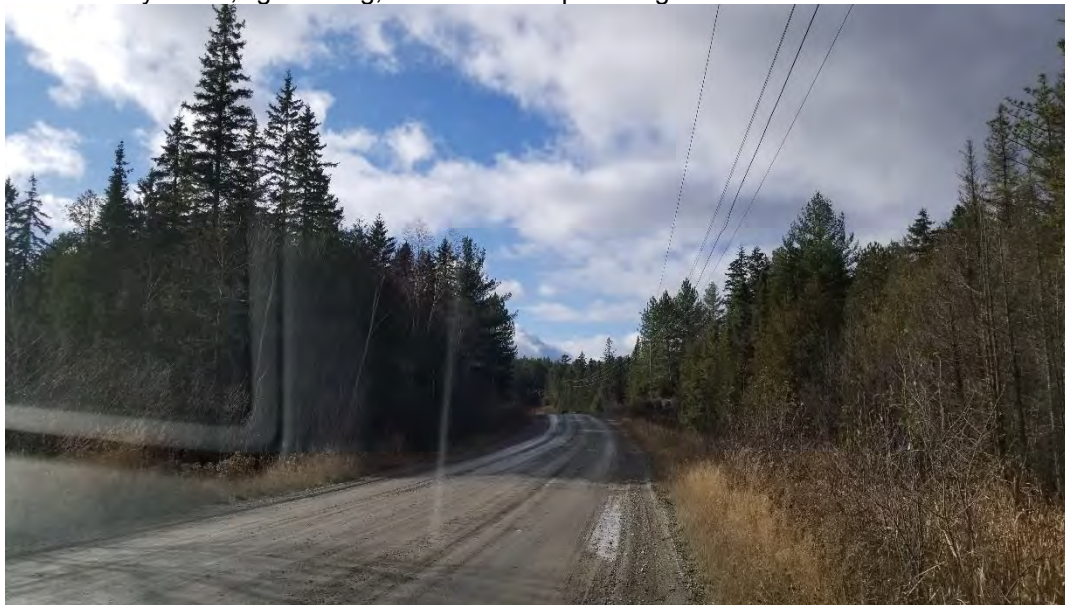
Picture 7 – Distress Area #7 (North on Right)

- 10.85 to 11.0 km
- Swampy area on both sides, North side holding water.
- Culvert #23 heaved above water level on North side.
- Roadway is wet, light rutting, and moderate potholing.

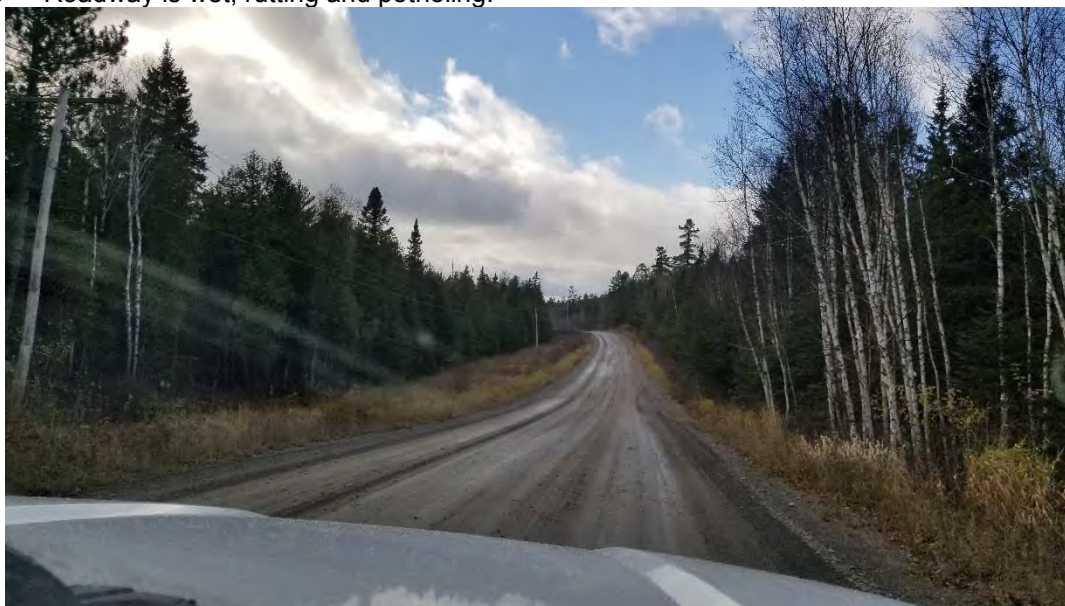
Picture 8 – Distress Area #8 (North on Right)

- 11.4 to 11.5 km
- Low point, swampy area on both sides, road grade approximately 0.6m above water level.
- Roadway is wet, rutting and potholing.

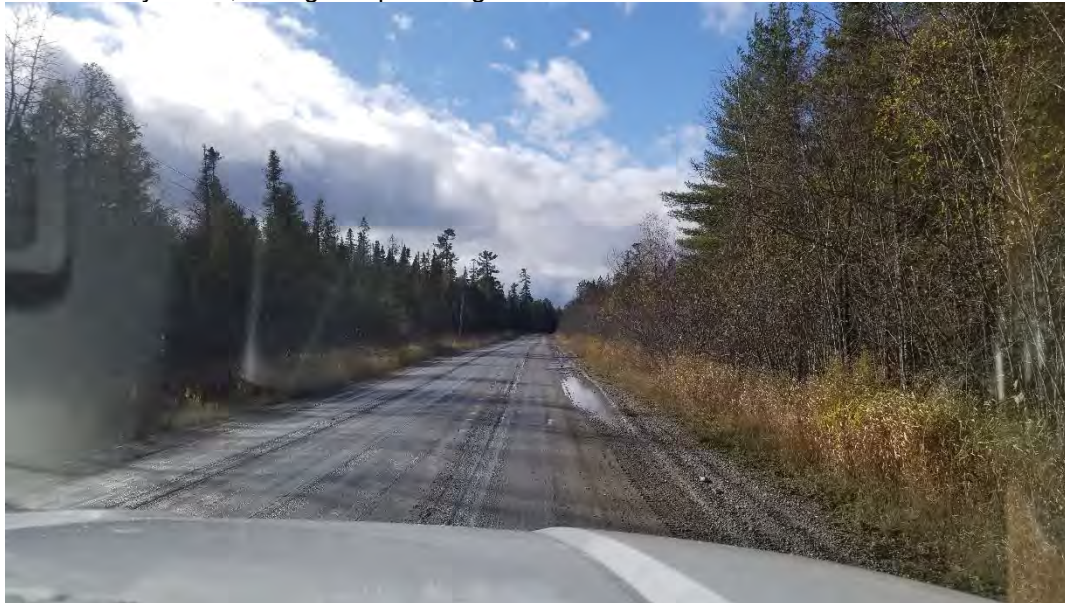
Picture 9 – Distress Area #9 (North on Right)

- 12.05 to 12.15 km
- Swampy area both sides, road grade approximately 0.5m above water level on South side and 0.3m on North side.
- Roadway is wet, rutting and potholing.

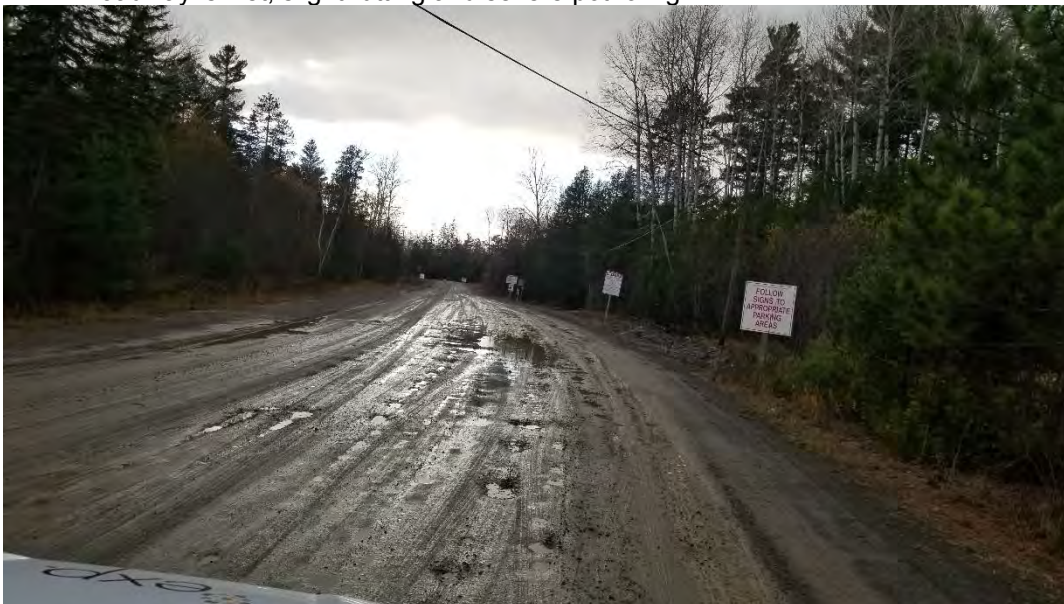
Picture 10 – Distress Area #10 (North on Right)

- 16.65 to 16.80km
- Swampy area on South side, North side recently ditched.
- Roadway widens to approximately 16 m wide, minimal crossfall on roadway.
- Roadway is wet, slight rutting and severe potholing.

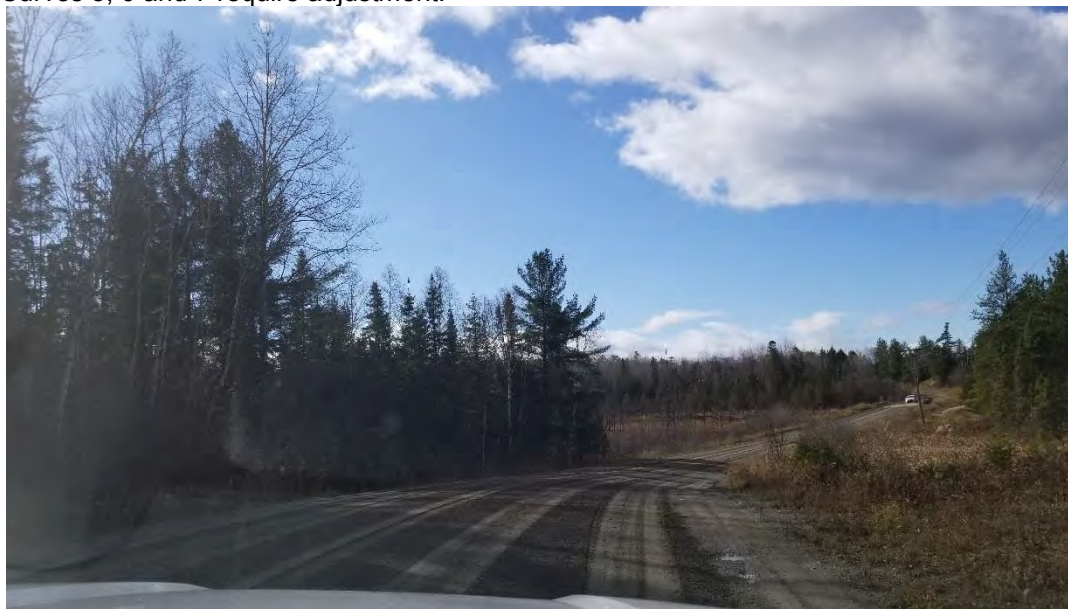
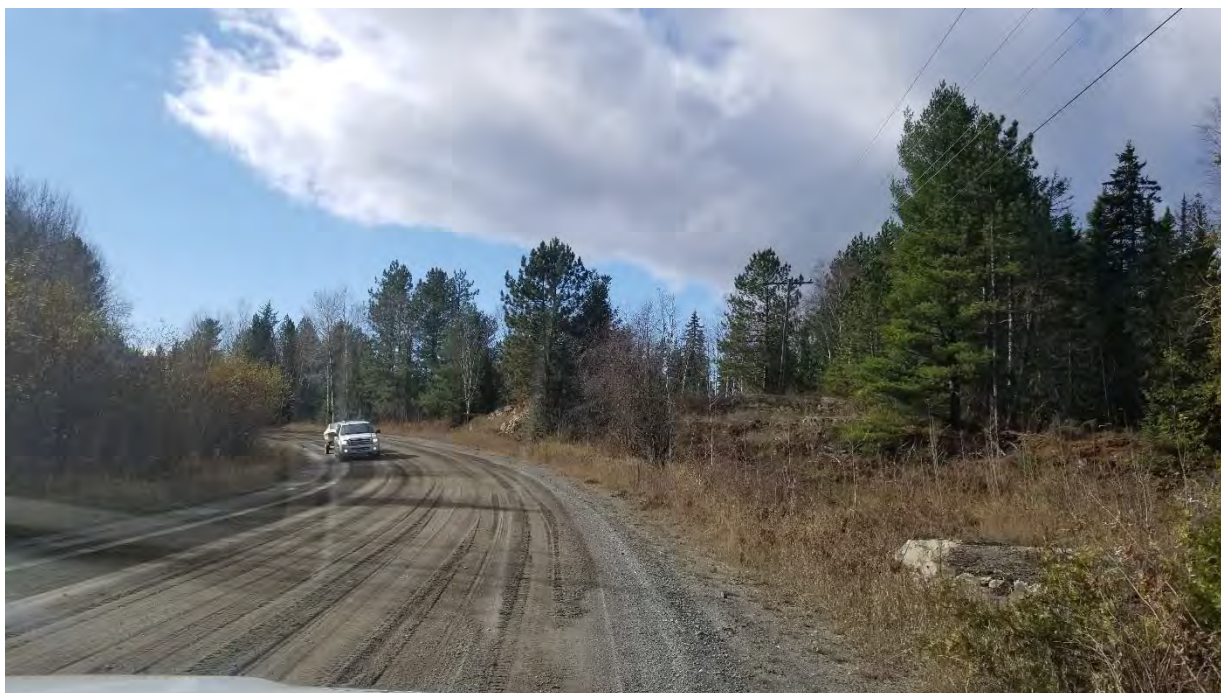
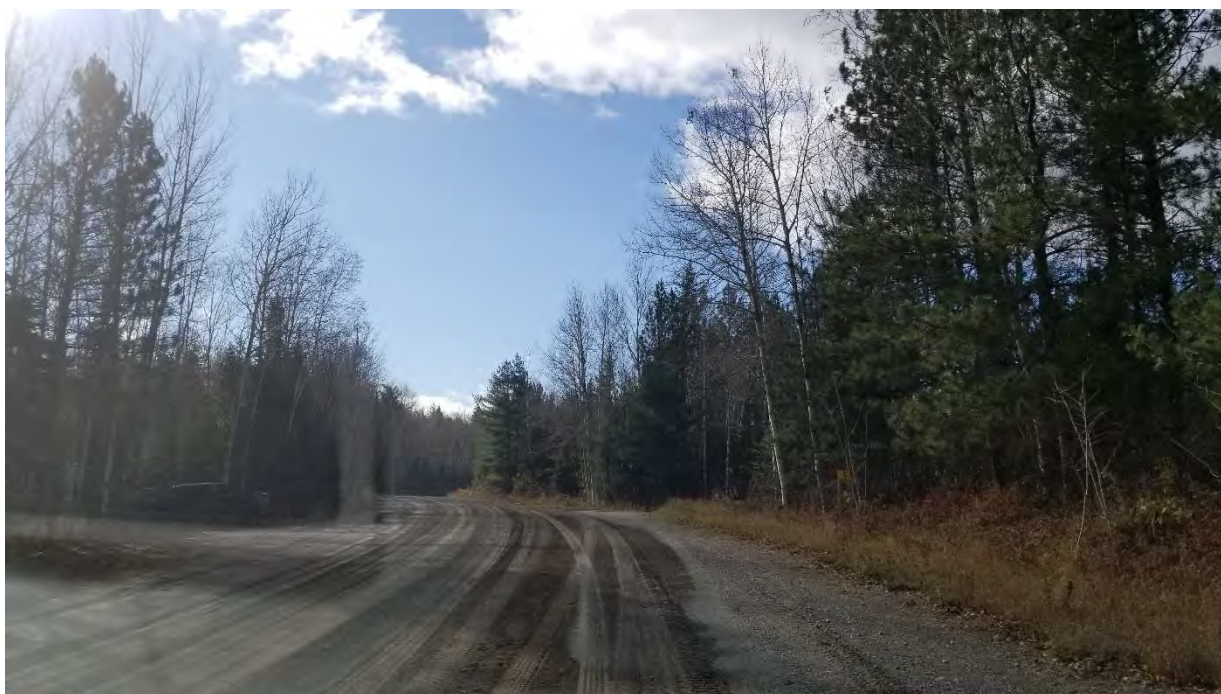
Per Table C3-5 of the *Geometric Design Standards for Ontario Highways, 2002* the minimum curve radius for a secondary highway with a design speed of 80 km/h is 250m. Based on this minimum radius, 22 of the 50 curves identified in **Table 2** are substandard\*.

- 4.60 to 5.29 km
- Curves 5, 6 and 7 require adjustment.

We recommend the realignment of the substandard horizontal curves identified in **Section 5.3**.

Realigned portions of the road should be constructed according to OPSD 200.010, 201.010, 203.010, 203.020, 209.020 (See Appendix), as appropriate.

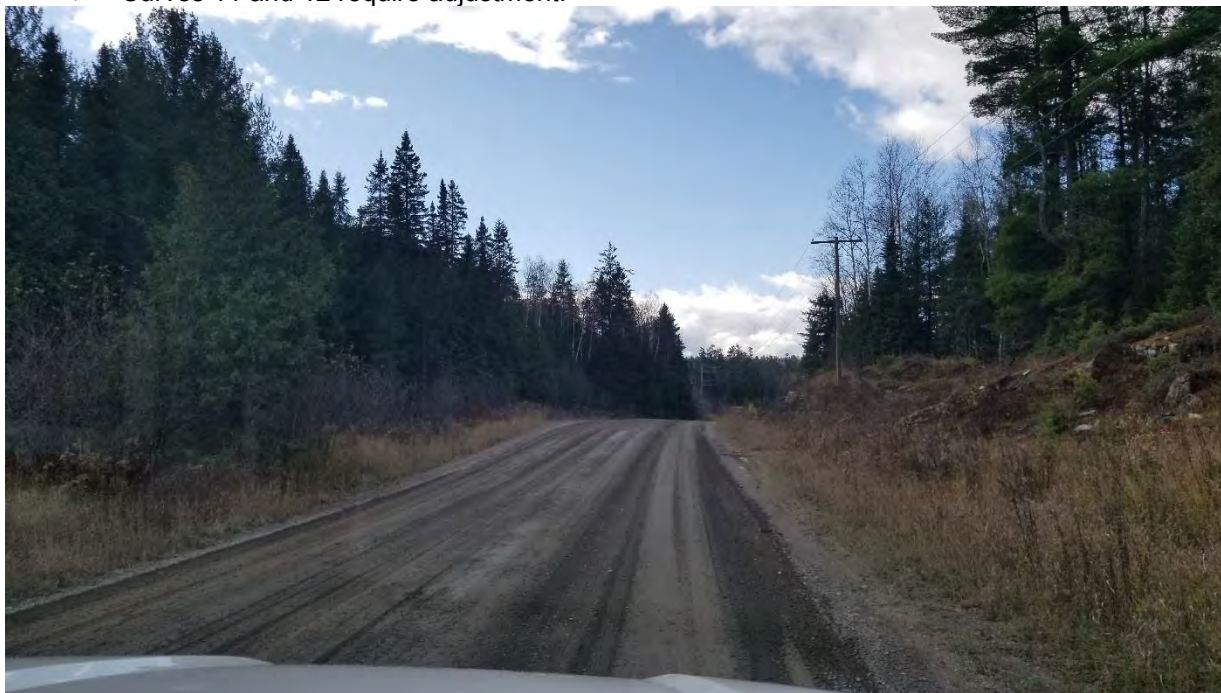
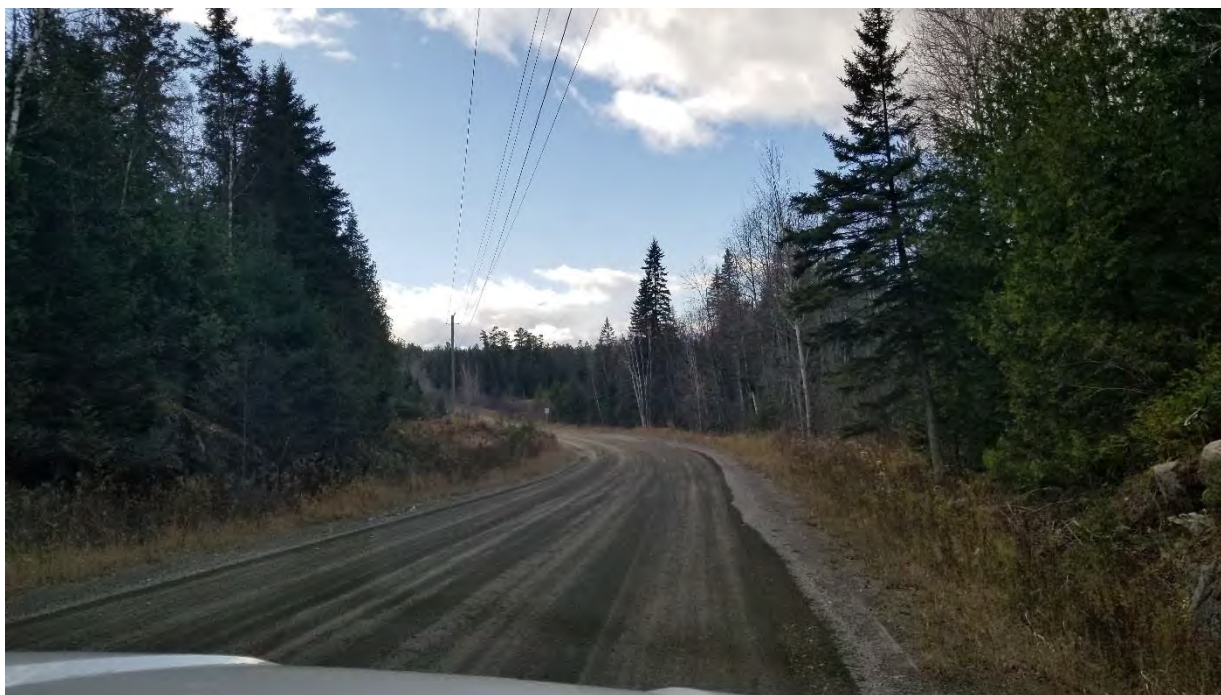
- 6.48 to 6.81 km
- Curves 11 and 12 require adjustment.

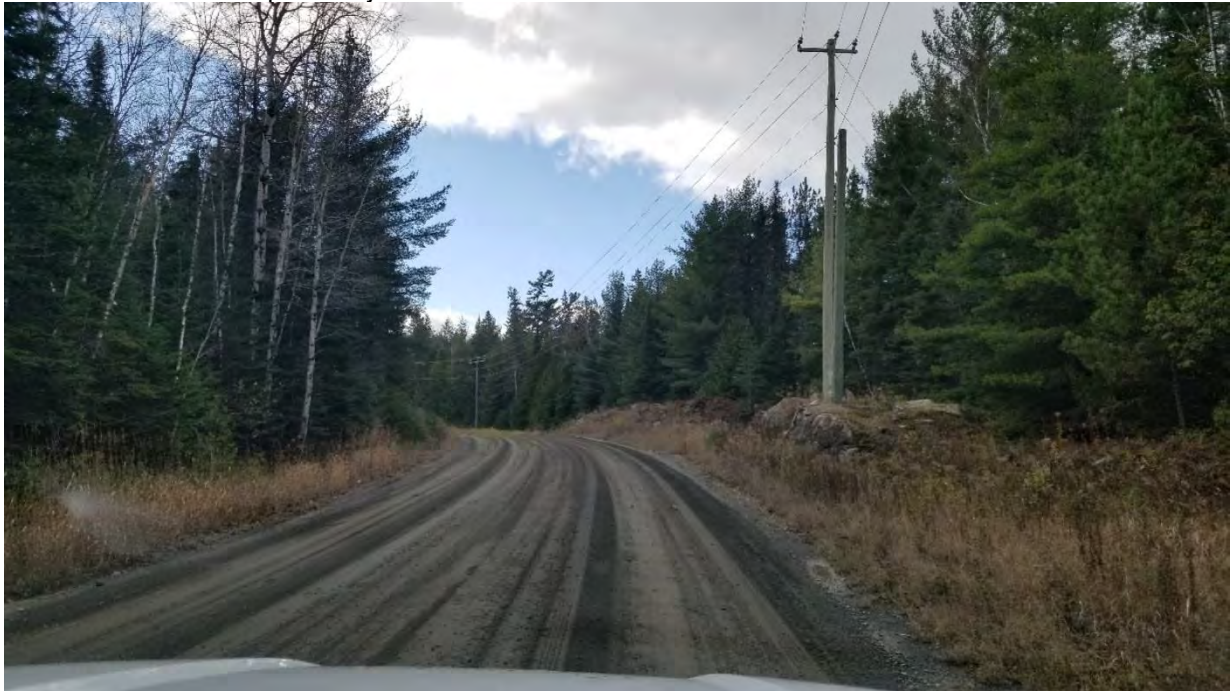
Picture 16 – Horizontal Realignment Area #3 – Curve 14 (North on Right)

- 7.04 to 7.23 km
- Curve 14 requires adjustment.

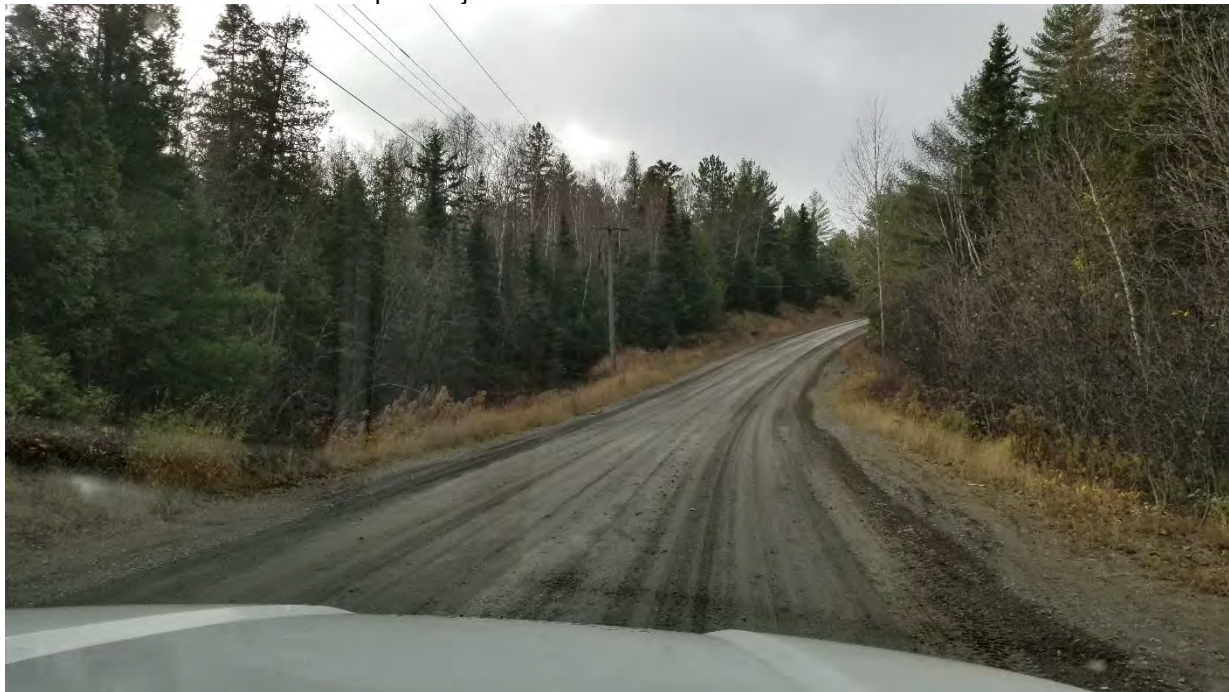
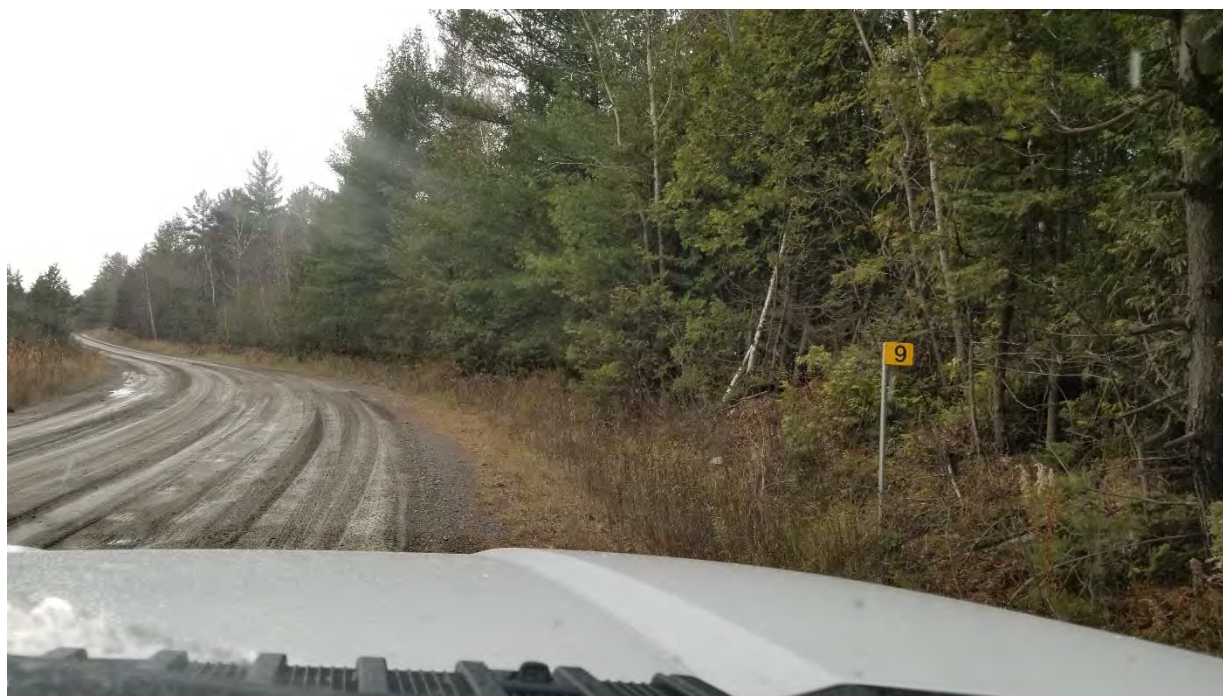
- 8.80 to 9.22 km
- Curves 20 and 21 require adjustment.

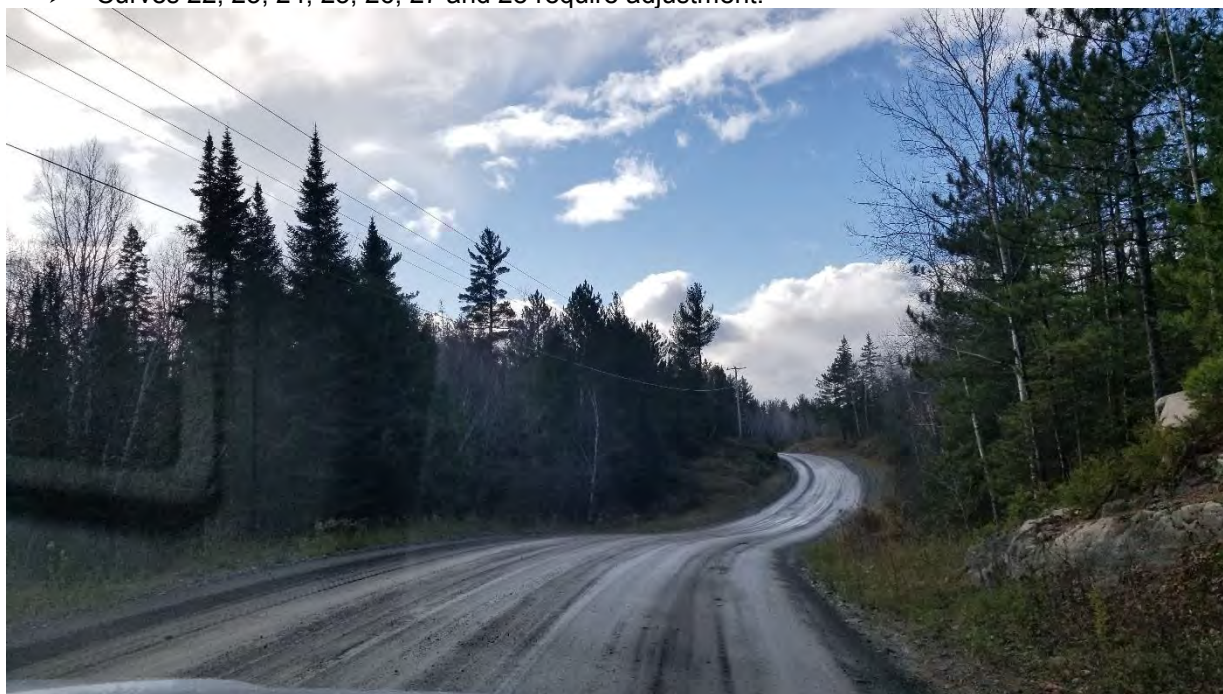
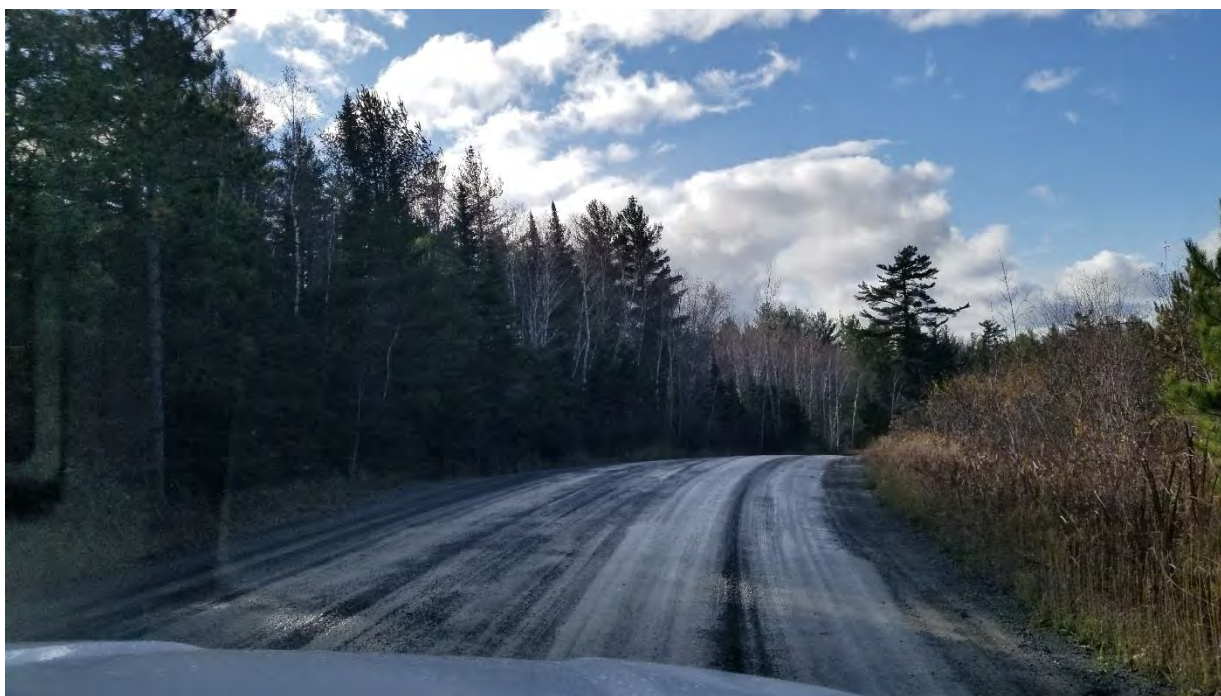
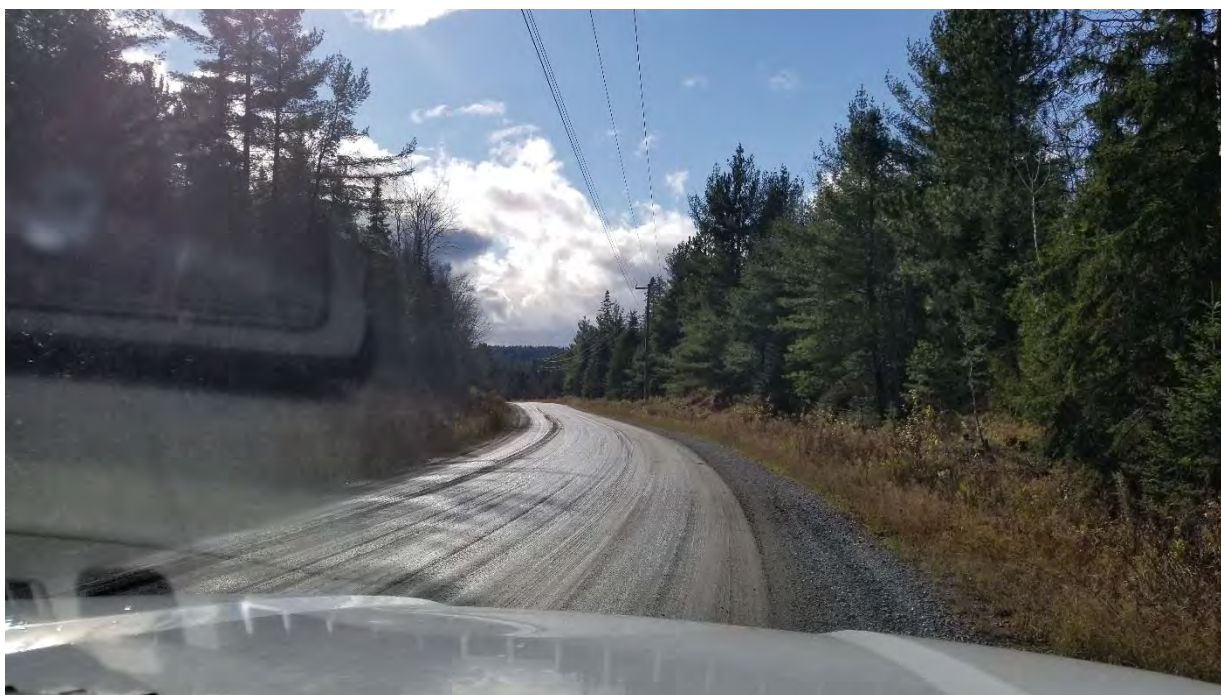
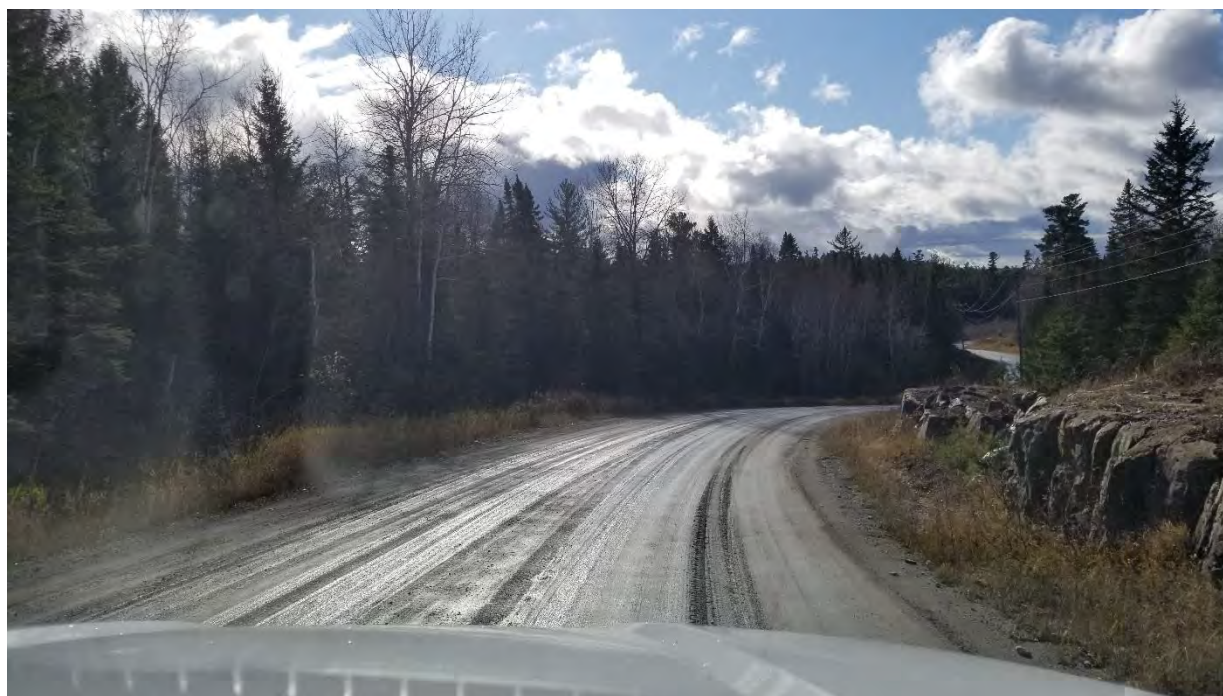
- 9.43 to 10.61 km
- Curves 22, 23, 24, 25, 26, 27 and 28 require adjustment.

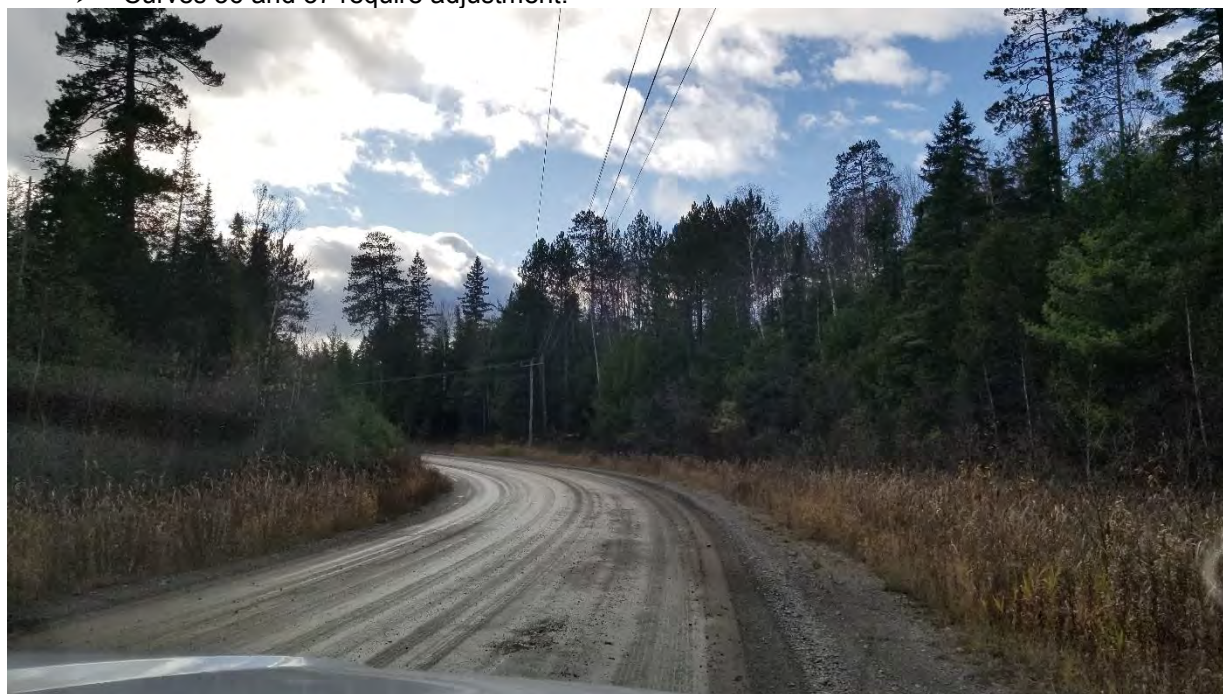
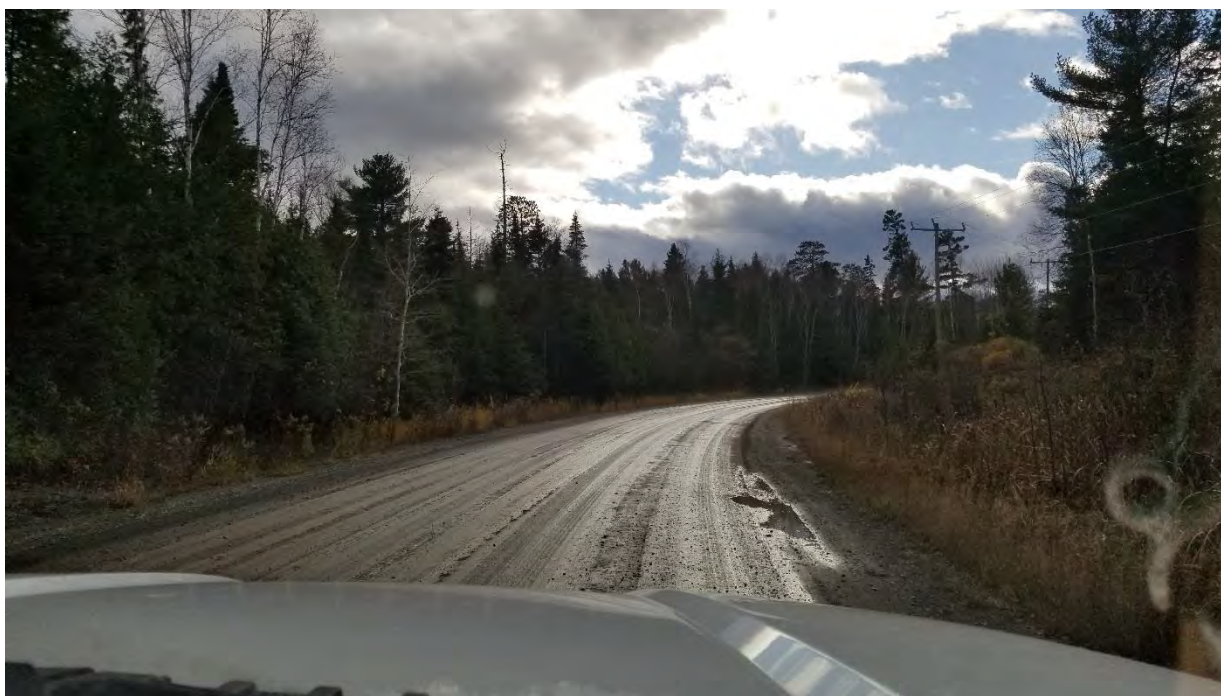
- 12.95 to 13.55 km
- Curves 36 and 37 require adjustment.

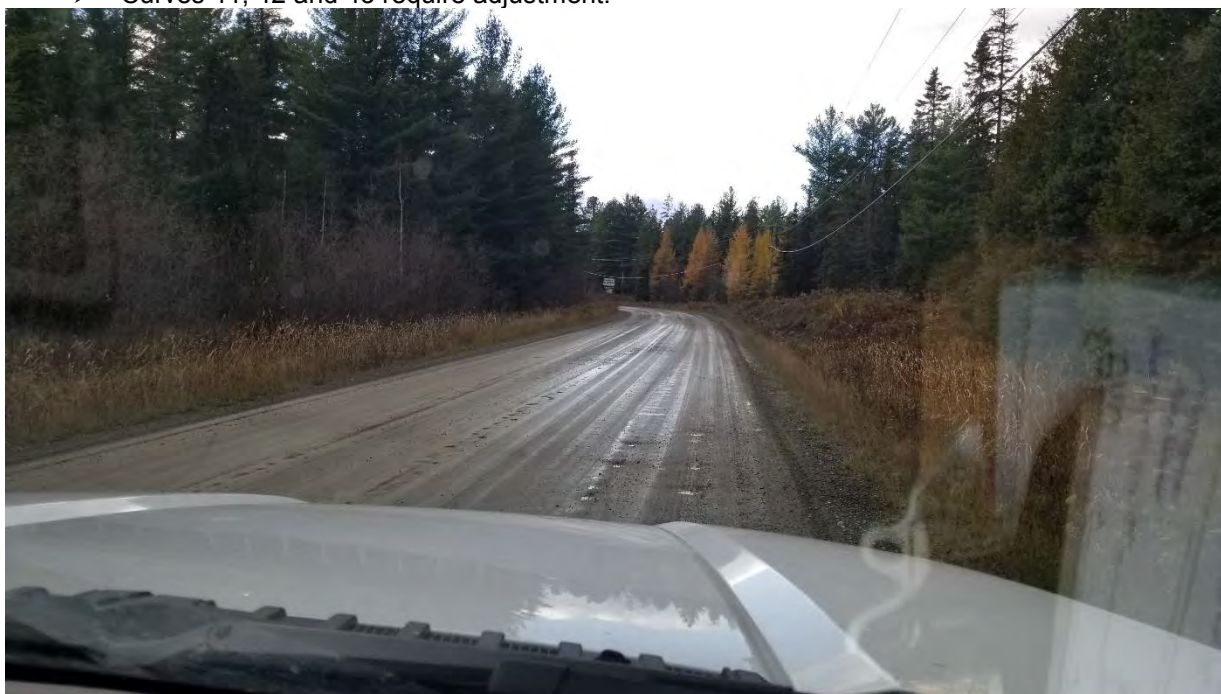
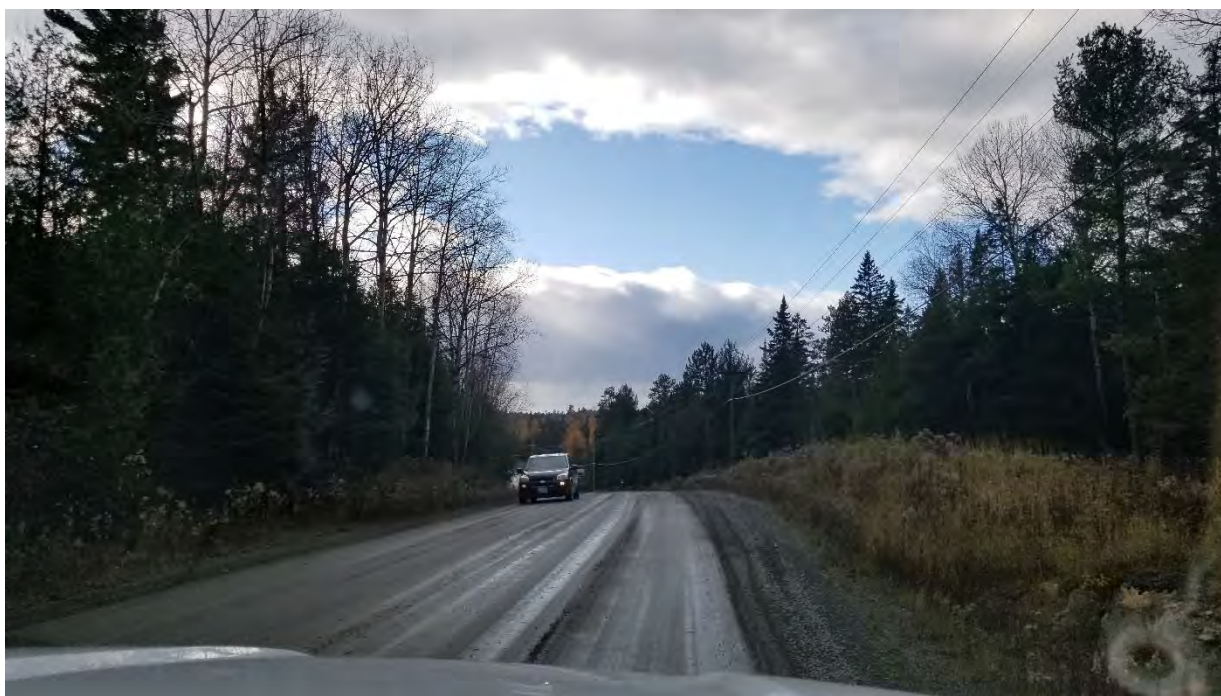
- 14.79 to 15.30 km
- Curves 41, 42 and 43 require adjustment.

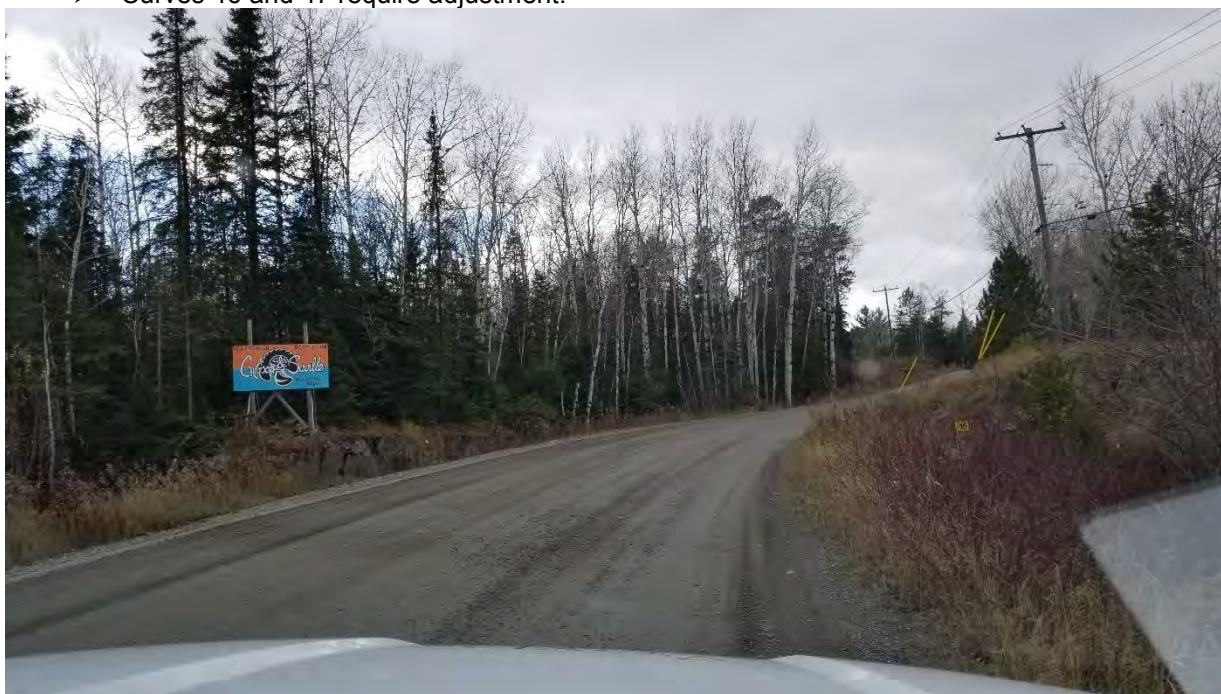
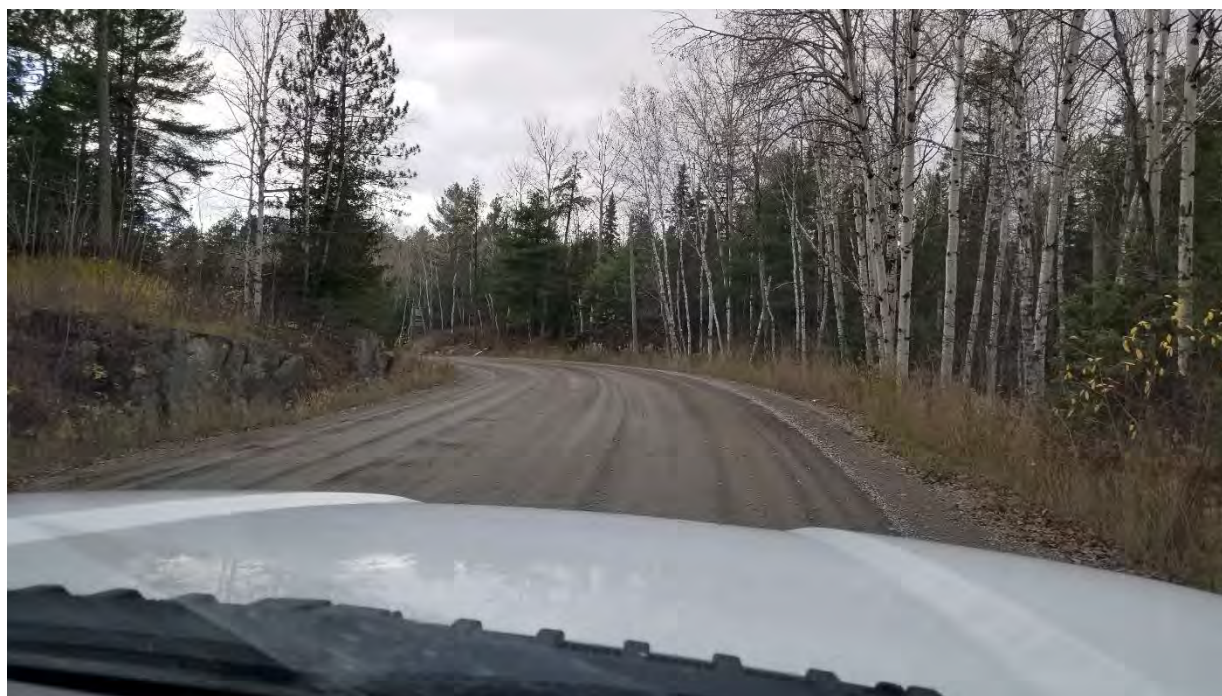
- 16.22 to 16.65 km
- Curves 46 and 47 require adjustment.
