Structural Inspection Report

Caribou Mountain Tower

Temagami, Ontario

P-SEC Project Number 17510

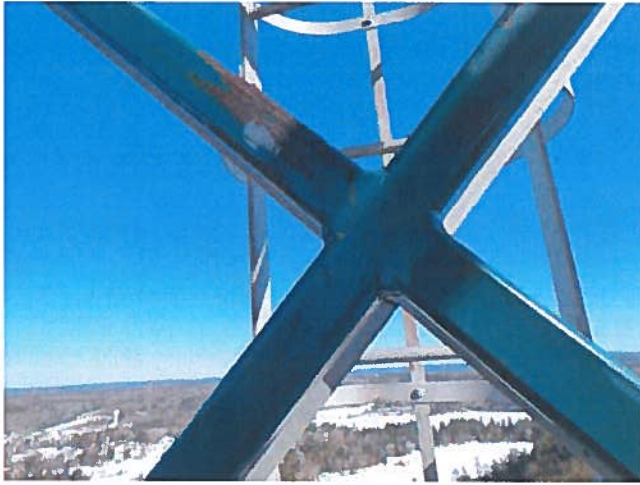
**Deficiency #1**

At an elevation of 23.5m on face DA on leg D side near the center the top section of the diagonal has started to split at a corner.

Grind off rust down to sound metal and repair member by adding weld. Ensure weld if ground flush before applying cold galvanizing.

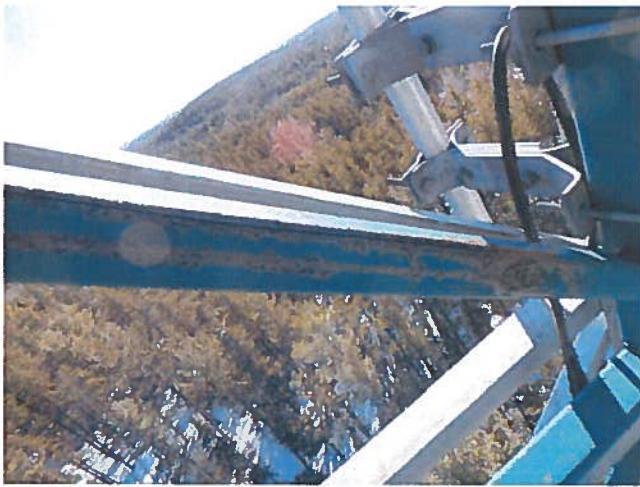
**Deficiency #2**

At an elevation of 22.5m on face AB on leg B side near the leg the bottom section of the diagonal has started to split at a corner.

Grind off rust down to sound metal and repair member by adding weld. Ensure weld if ground flush before applying cold galvanizing.

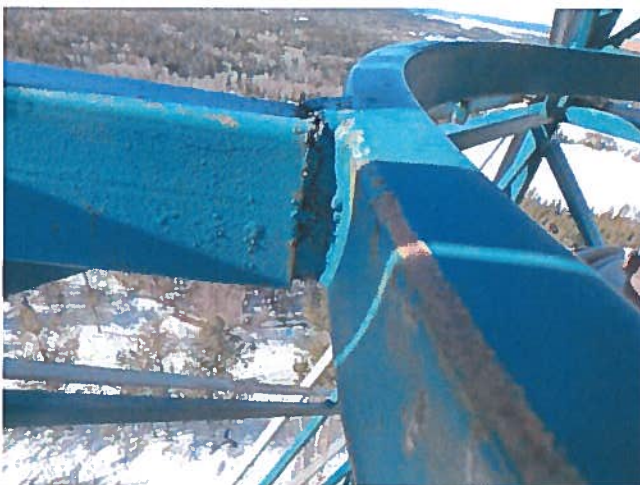
**Deficiency #3**

At an elevation of 24.7m from leg B to the curved support there is a small portion of rectangular HSS that has cracked/poor welds. This appears to possibly have been a previous fix not properly welded.

Remove poor welds and re-weld rectangular HSS at both ends.

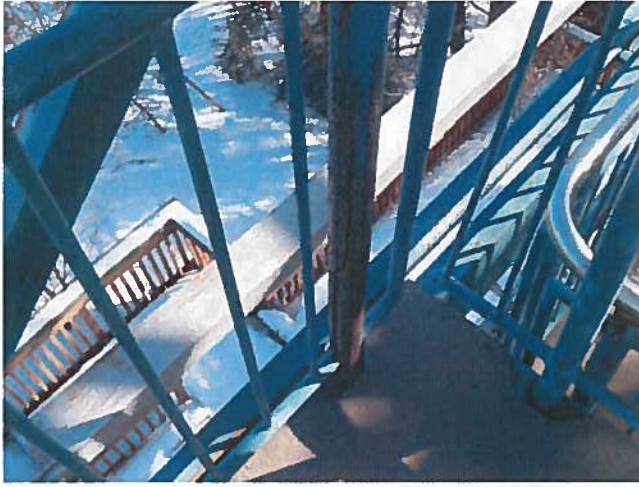
**Deficiency #4**

At an elevation of 6.71m inside face DA near leg D there is a handrail baluster that is fractured.

Replace baluster.

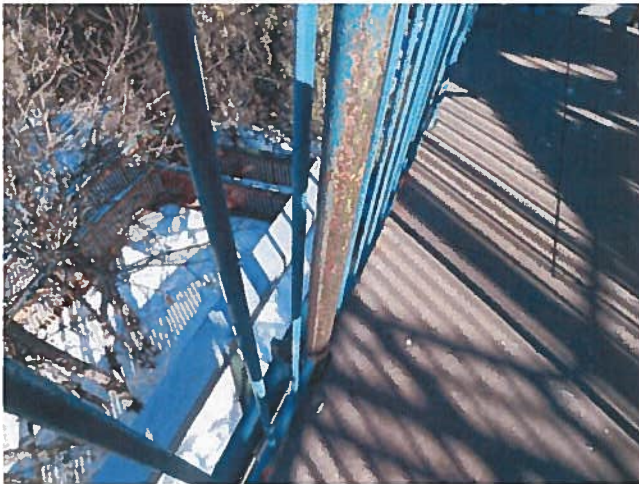
**Deficiency #5**

At an elevation of 6.71m inside face CD near the center of the face there is a handrail baluster that has just started to fracture.

Replace baluster.

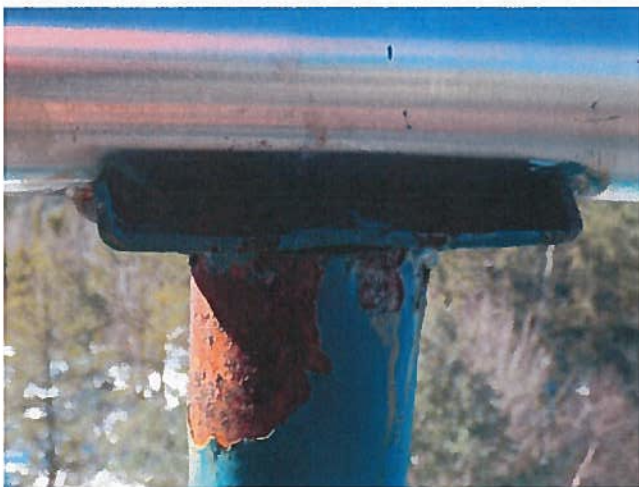
**Deficiency #6**

While on site we investigated possible causes for the cracked platform balusters and it appears that the saddles that attach the balusters to the rail are warped and water has been able enter the baluster. This occurs at multiple locations throughout the tower so we recommend either welding to seal these or drilling weep holes to allow any water to drain out.

At multiple locations on the tower the handrail saddle at the top of the posts has separated from the post creating a gap where water can enter.

Re-weld the saddle to the posts or install a weep hole at the bottom of the posts to prevent water buildup.

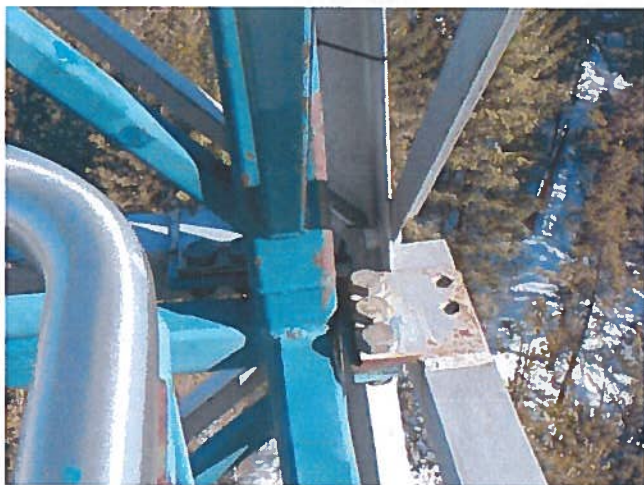
Deficiency #7
Weep holes have not been installed on the majority of the members throughout the tower.

Recommendation
Based on the presence of (2) diagonal members that appear to have split installing weep holes at the bottom end of all continuous HSS members should be considered.

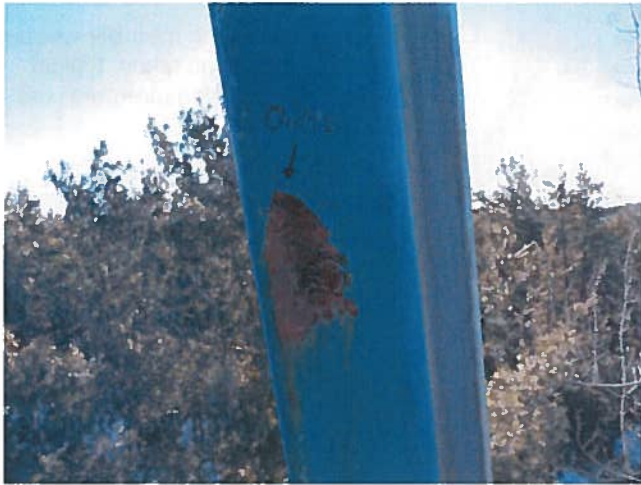
Area of rust on leg member where a measurement was taken, typical reading between 0.295 and 0.285. Measurement was 0.295.

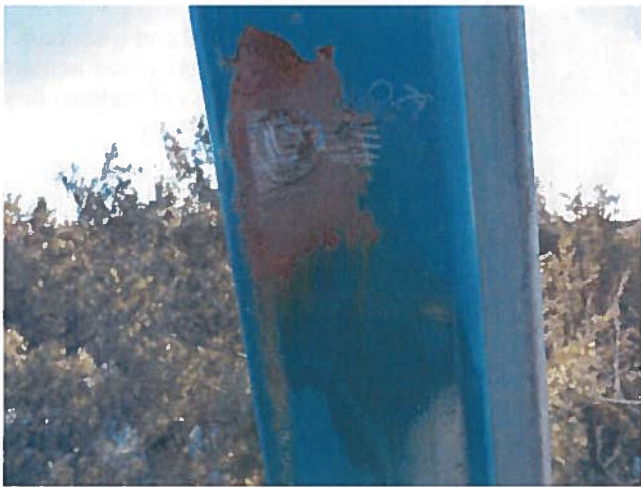
Rust was removed and a second measurement taken, measurement was 0.29. No significant loss of material has occurred.

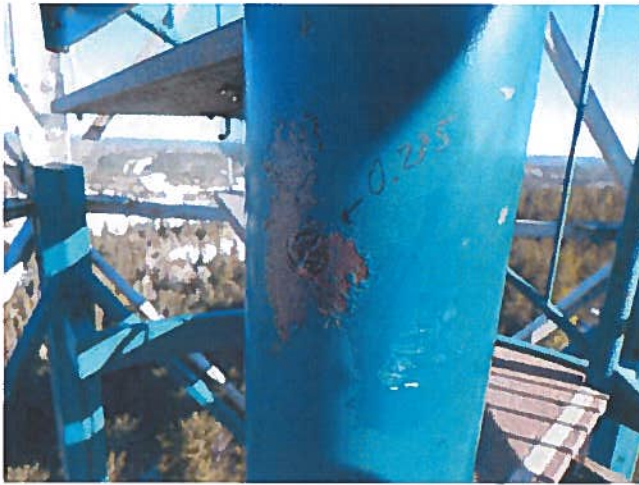
Area of rust on leg member where a measurement was taken, typical reading 0.235. Measurement was 0.235.

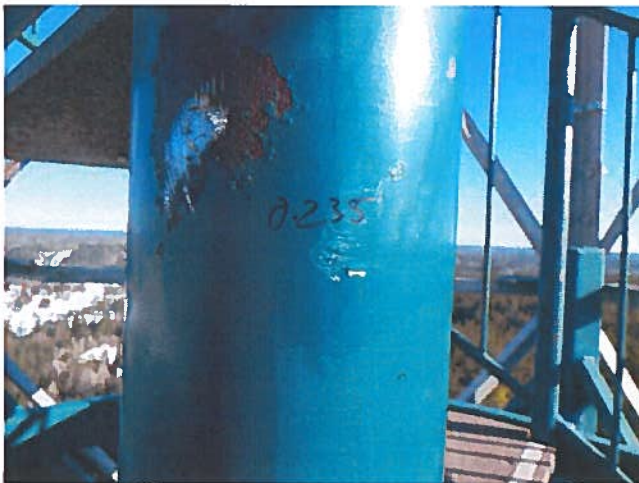
Rust was removed and a second measurement taken, measurement was 0.235. No loss of material has occurred.
