**Subject:** Temagami North and South Sewage Lagoons - 2024 Annual Performance

**Memo No:** 2025-M-082

# **2024 Annual Performance Report for the Temagami North Sewage Treatment Lagoon & Sewage Collection System**

# **2024 Annual Performance Report for the Temagami South Sewage Treatment Lagoon & Sewage Collection System**

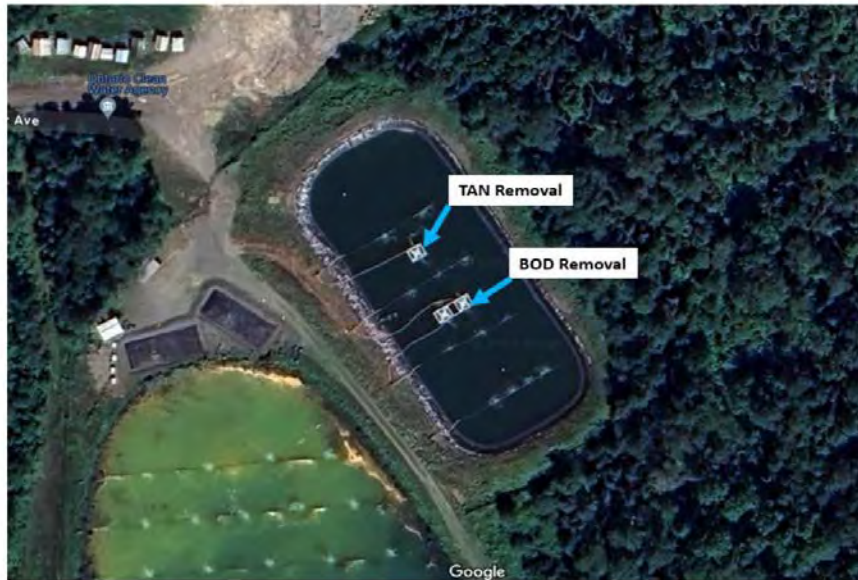
*Figure 1 – Location of BIOFIXE Modules*

- Three (3) BIOFIXE modules were installed in Cell No. 1 in June of 2022 as a pilot project for BOD and ammonia removal. The first two units were positioned to remove BOD load and the third unit was positioned to remove ammonia as shown Figure 1 below.

The floating units are anchored in the middle of the lagoon for optimal air dispersion. Three (3) stainless steel valves and three (3) pressure gauges were added to the aeration lines to aid in the Biofixe system optimization.

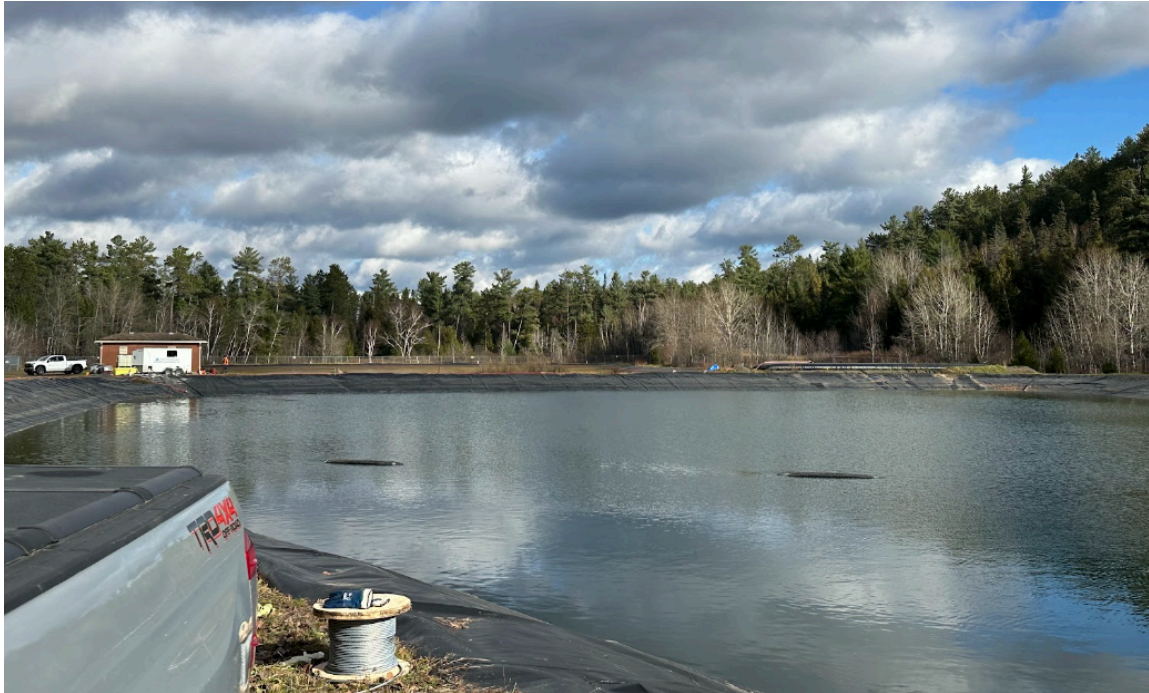
**Figure 1.** View the lagoon cell.

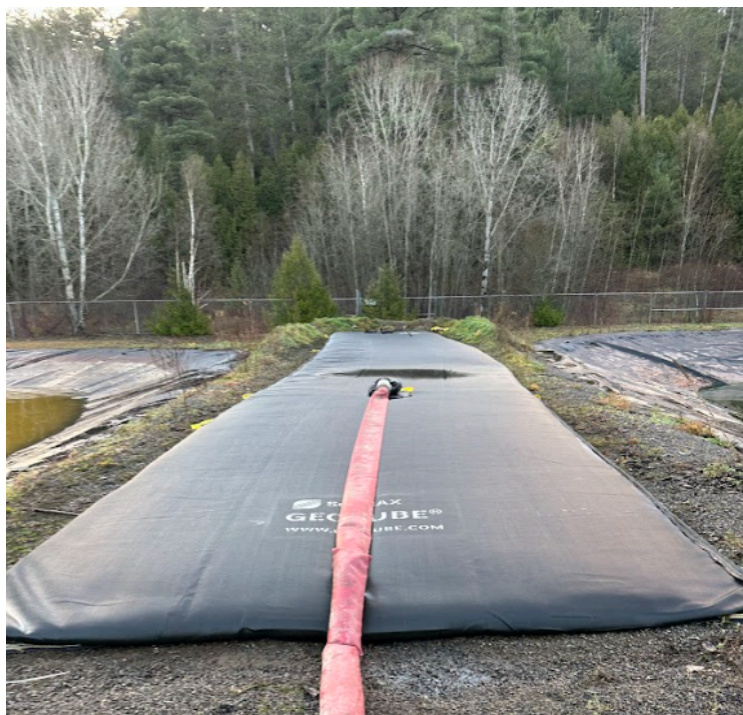
**Figure 2.** View of the Geotube unit onsite.

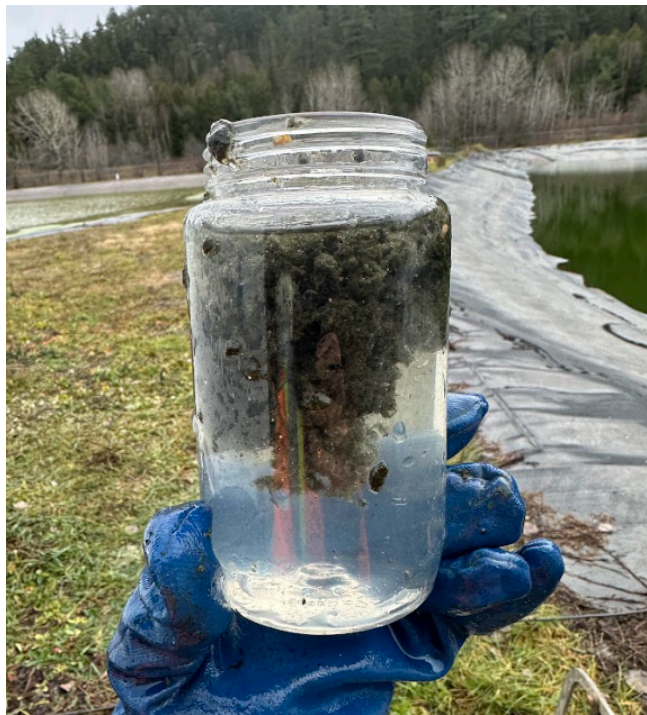
**Figure 3.** Sample of the lagoon sludge after treatment with Solve 137.

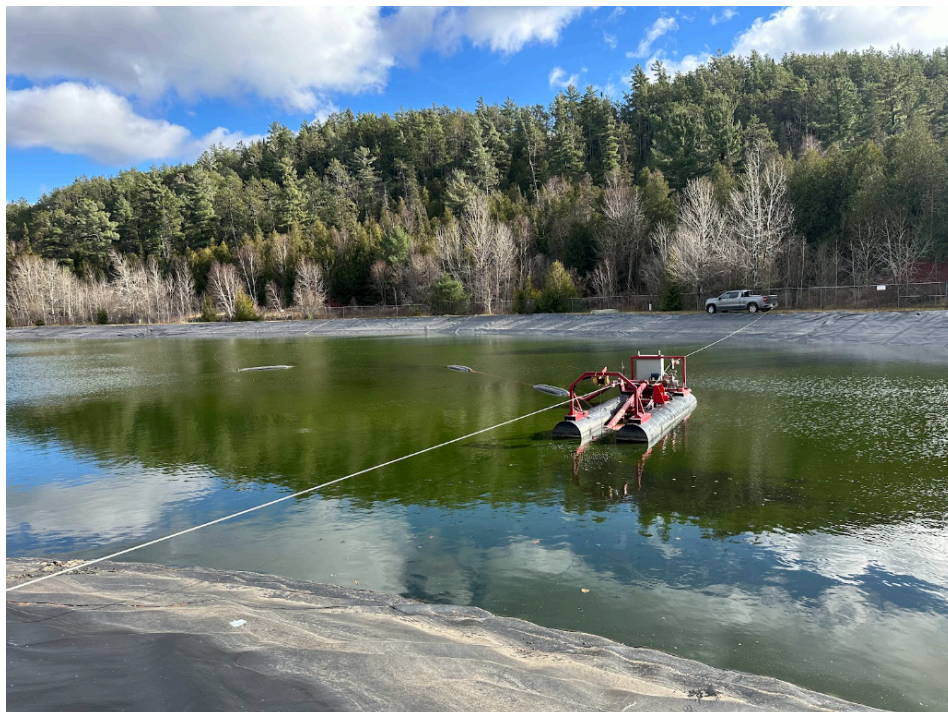
**Figure 5.** Dredge deployed into the lagoon cell.

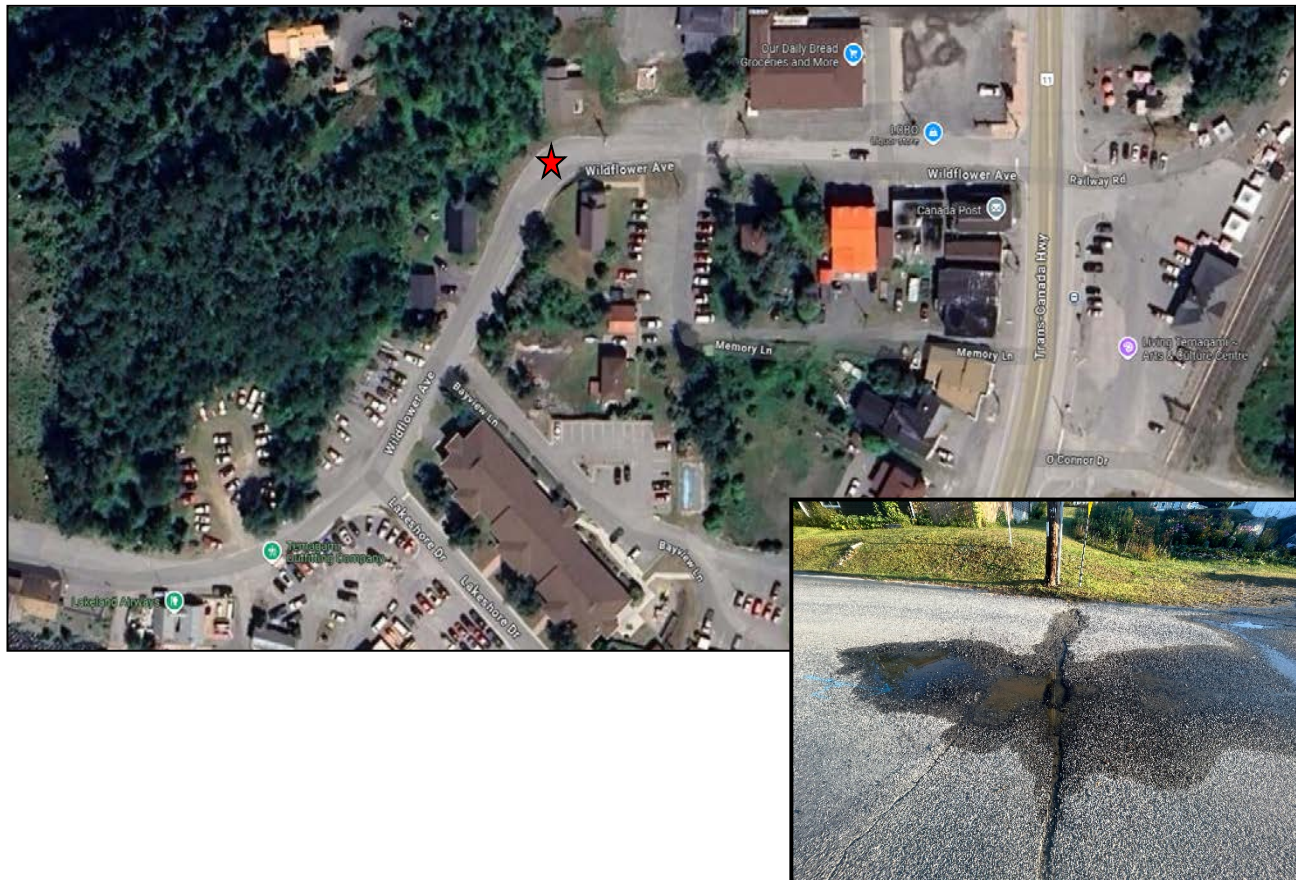
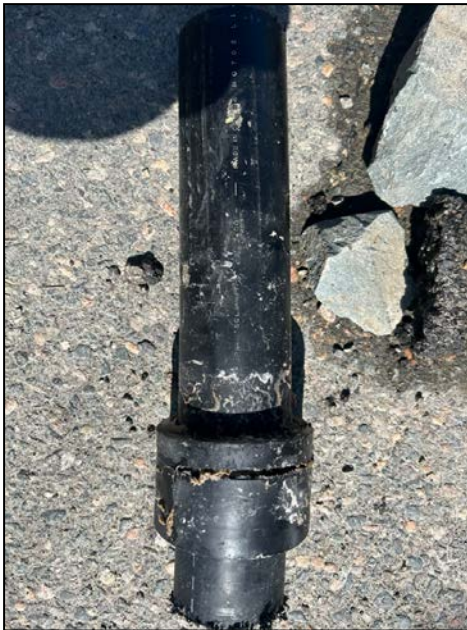
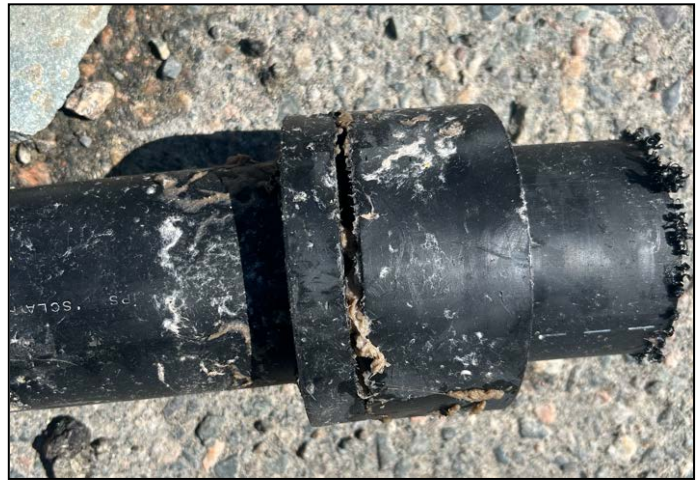
**Cracked Coupler**

OCWA responded to a call to investigate a sewer break at 18 Wildflower Avenue (approximate location shown on the map by red star). Sewage bubbled out of a crack in the road when the Temagami Shores sewage pumping station was running. The pumping station normally runs twice per day.

A vertical crack on the coupler likely caused by ground shifting.

The section of broken pipe was removed and replaced with a new 3" ABS pipe, approximately 18 " long and two victaulics to seal in place.

The Temagami Shores sewage pumping station was initiated remotely via SCADA to check for leaks. No leaks were observed and the station was placed back into normal operations.
