Re: **LMS Job #LM19081**  
**Remotely Operated Vehicle Inspection & Report (ROV) – Temagami North Standpipe (SP)**

## WELDED STEEL STANDPIPE INSPECTION REPORT

Re: **LMS Job #LM19081**  
**Remotely Operated Vehicle Inspection & Report (ROV) – Temagami North Standpipe (SP) –**  
**Protective Coatings & Linings Report**

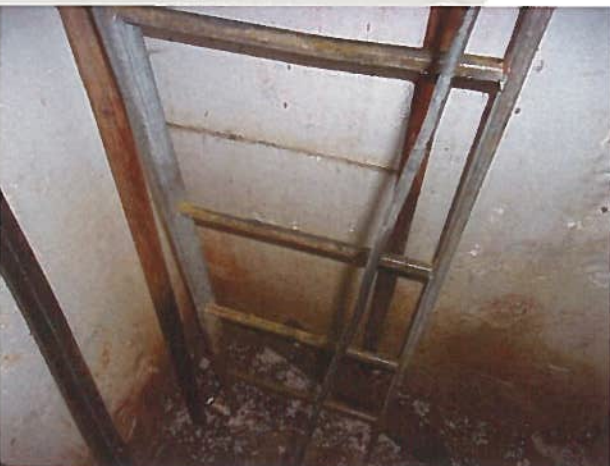
15

<b>LADDER TO TANK ROOF</b>		Minor to moderate surface corrosion throughout	14 - 16
<b>TOP LANDING</b>		None - galvanized top landing assembly recommended to ensure safe transition to roof surface	67
<b>REST SEATS</b>		None - 1pc recommended	52
<b>ROOF HATCHES</b>	* Size	1pc - 36" x 36" aluminum hatch 1pc - 30" diameter steel hatch	71, 94

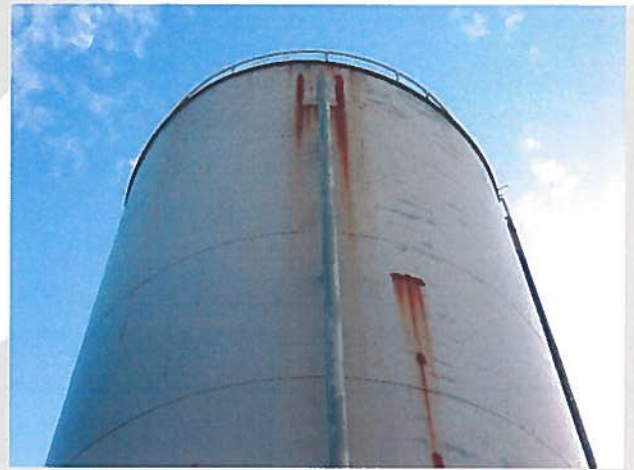
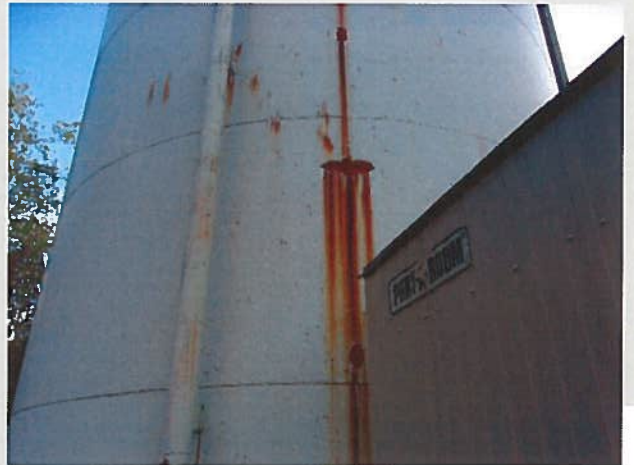
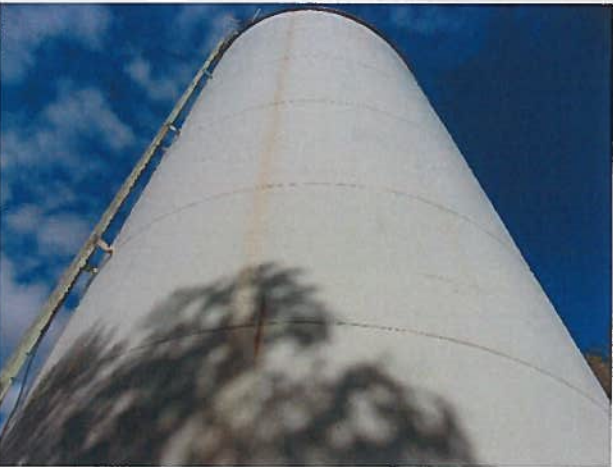
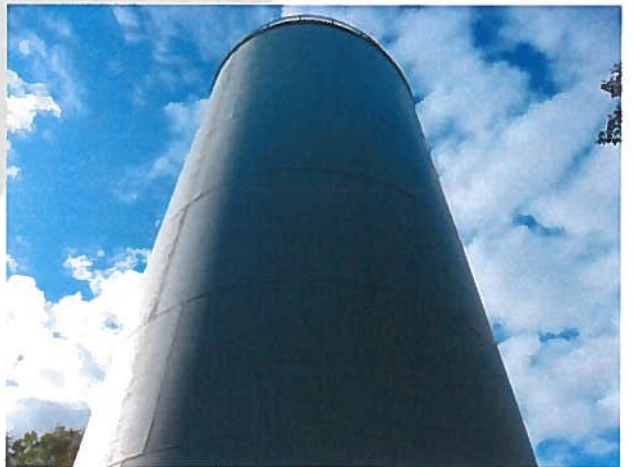
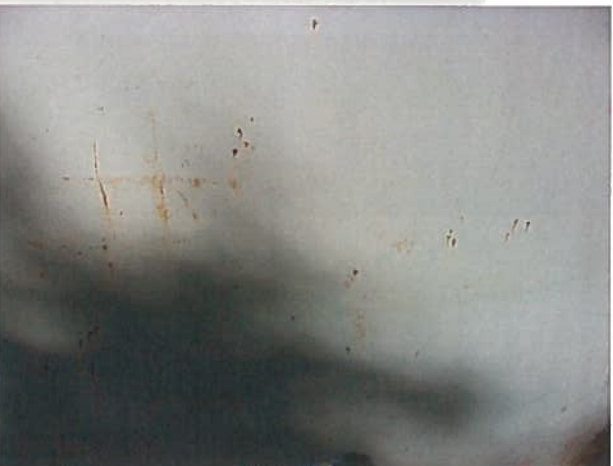
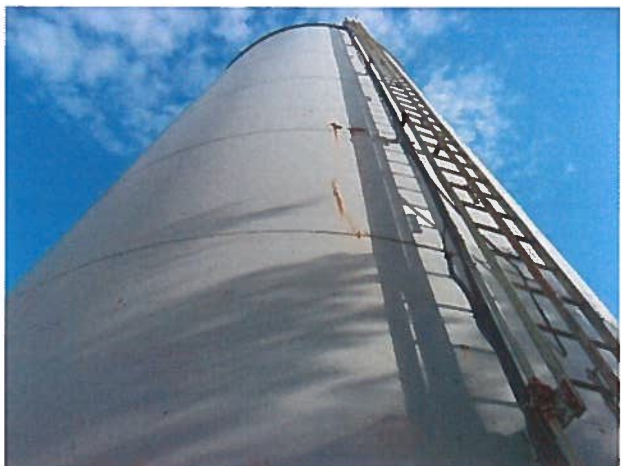
CONDITION OF SHELL PLATE	Structurally - Good; Coatings - Poor	26 - 32
ROOF CONDITION	Structurally - Good; Coatings - Poor	92 - 115
FLOOR PLATE CONDITION	N/I due to sediment accumulation	133 - 143

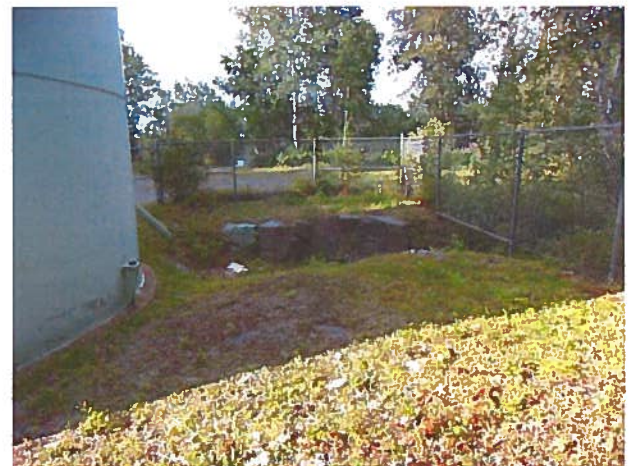
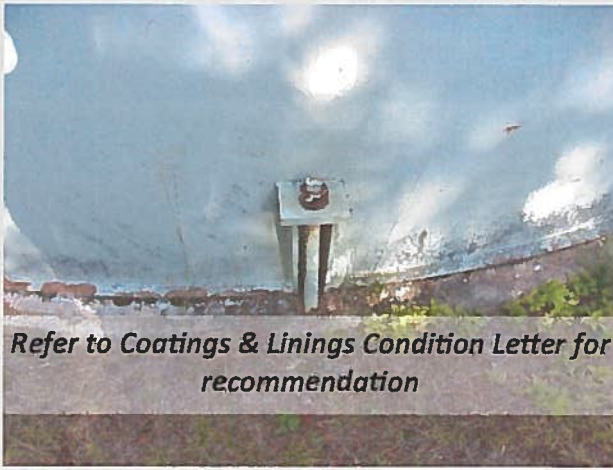
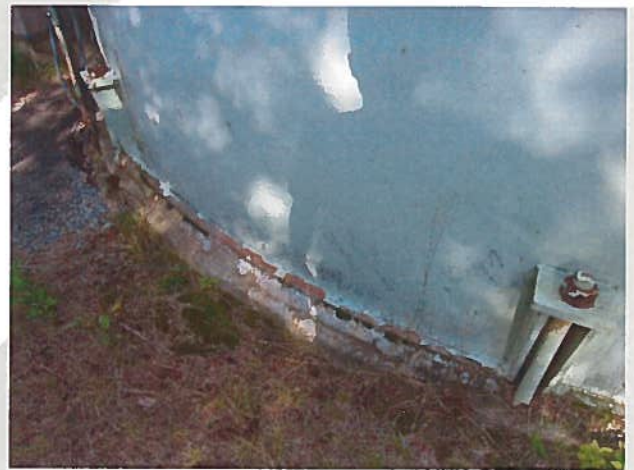
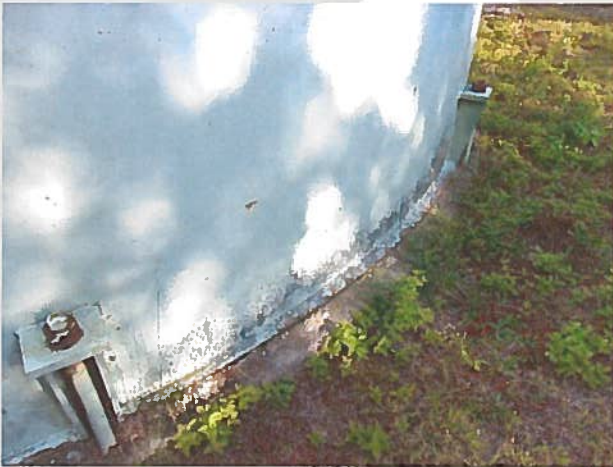
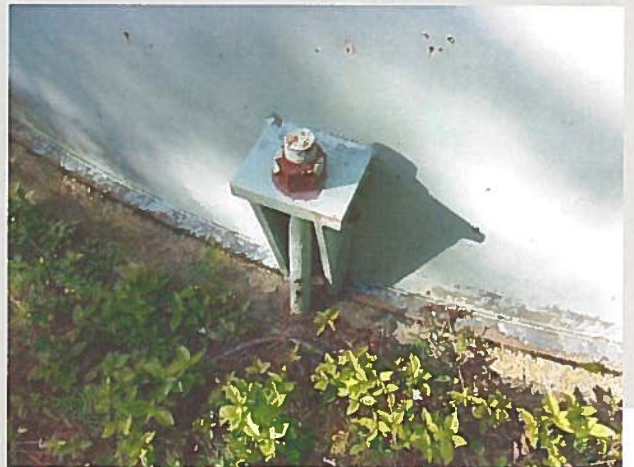
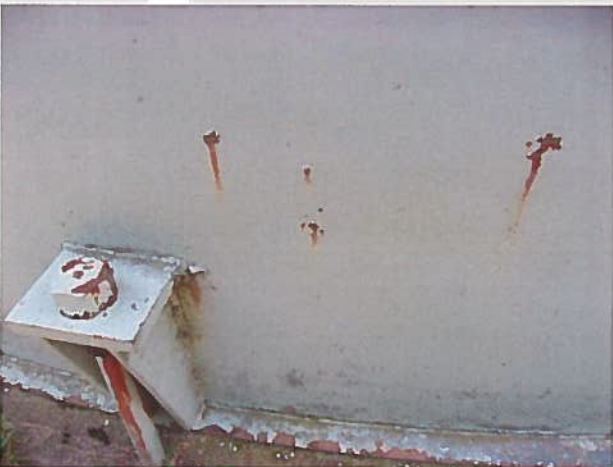
IS BASE PLATE DETERIORATED OR IN POOR CONDITION?	Moderate corrosion	39 - 46
ARE ANCHOR BOLTS & NUTS DETERIORATED OR IN POOR CONDITION?	Moderate corrosion	39 - 46
ARE ANCHOR BOLT CHAIRS DETERIORATED OR IN POOR CONDITION?	Moderate corrosion	39 - 46
ARE ANCHOR BOLTS TIGHT?	Yes	39 - 46
CONDITION OF STRAP ANCHORS?	N/A	--

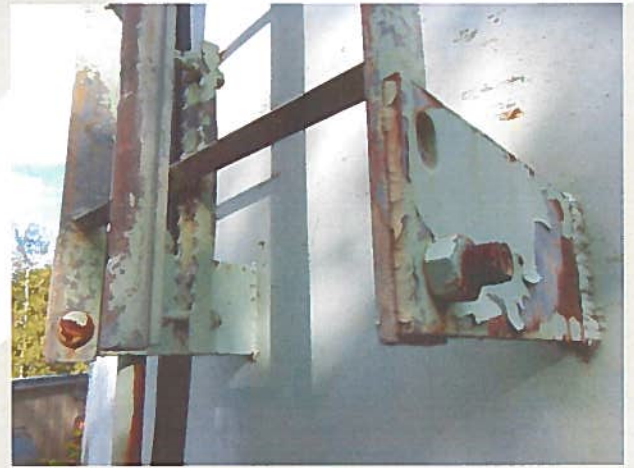
LOCATION	YES / NO	CONDITION	
* To Roof	No	--	68
* On Roof	Yes	Good	93
* At bottom of Vertical Ladder	No	--	49

**'D' ring required at bottom of vertical ladder**

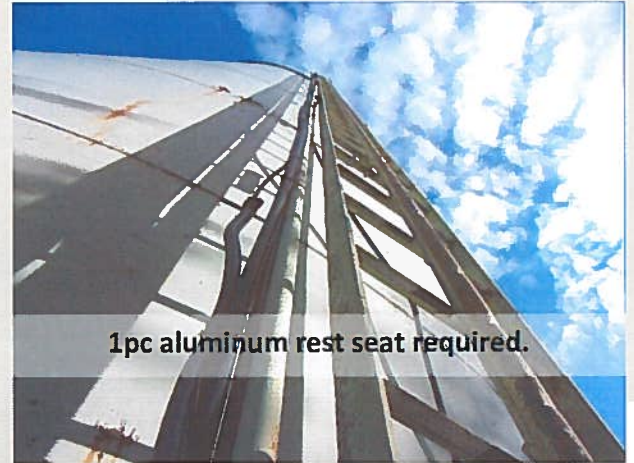
LADDER LOCATION	SYSTEM TYPE	COMMENTS	
* To Roof	Tube System	Remove and replace fall arrest system	51
* To Valve Pit	None	--	14

Remove and replace fall arrest system on vertical ladder

**Remove and replace fall arrest system**

**Ladder gate required**

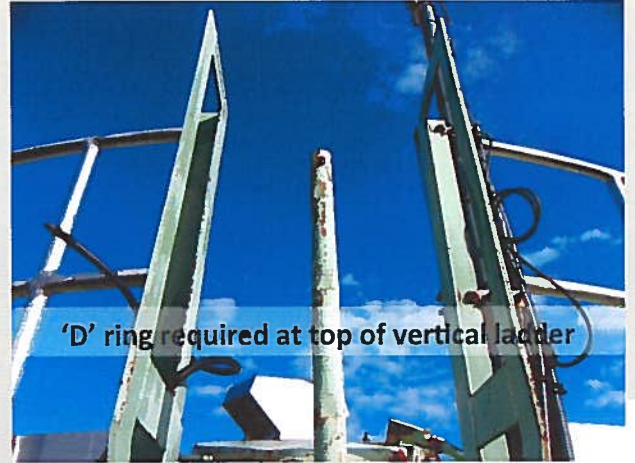
LOCATION	YES / NO	CONDITION	
* At Top of Vertical Ladder	No	--	67
* At Hatch to Tank Interior	No	--	92

Galvanized top landing assembly recommended

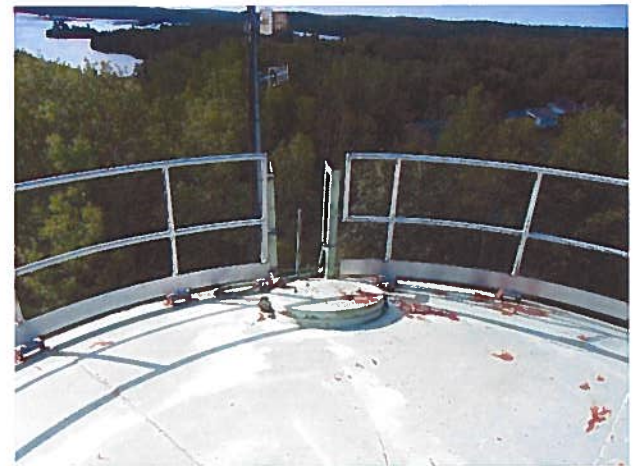
71

* Condition	30" - remove and replace original hatch system 36" x 36" - Hatch does not open fully due to recent handrail installation; padlock required	71, 94
<b>VENT</b>	* Type	16" S.S. Frostproof Combination vent / vacuum relief unit	89 - 91

Remove and replace original 30" roof hatch and curb

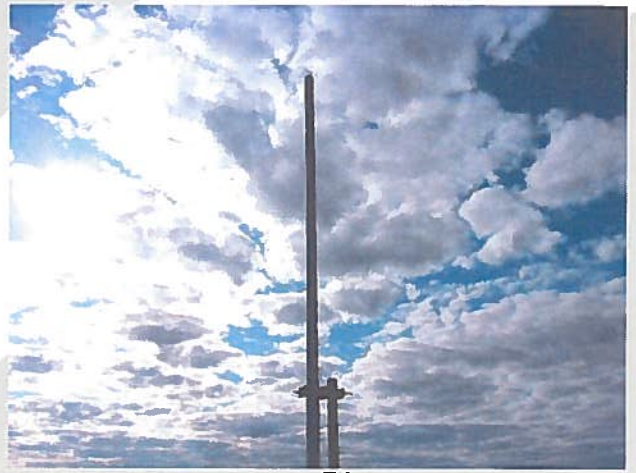
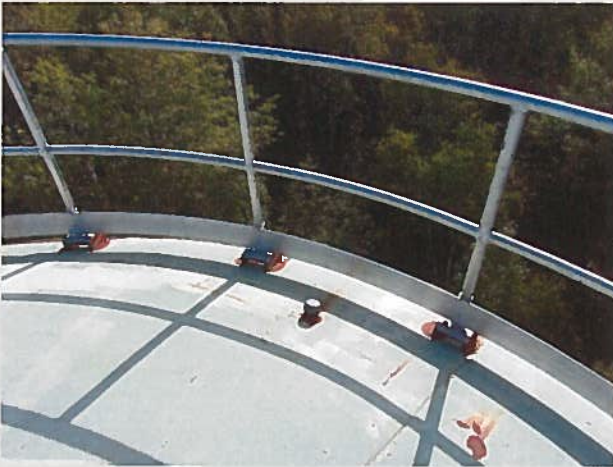
* Anchorage / Mounting	Fair	73 - 74
<b>CHLORINE ANALYSIS / DEAD ZONE TESTING</b>		Recommended	--
<b>MIXING SYSTEM</b>		Hydrodynamic system present. 2 stand-off brackets are damaged; corroded hardware should be replaced during next shutdown	148 - 154
