**Lake Temagami Access Road Improvement Study, 2017 – Project No. NWL-01701027**

## Lake Temagami Access Road Improvement Study, 2017

# **IMPROVEMENT STUDY**

## **Lake Temagami Access Road, 2017**

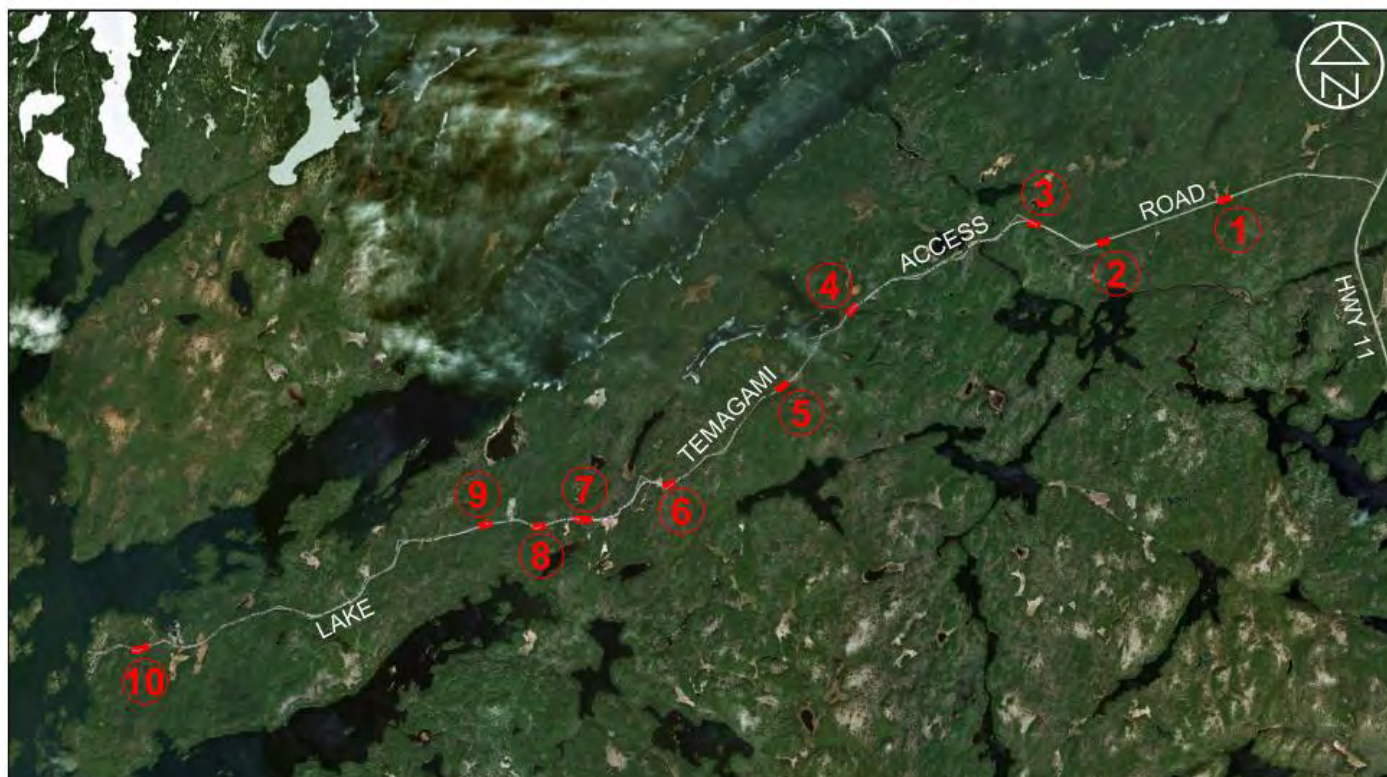
Figure 2: Distressed Areas Location Plan  
N.T.S.

The figure below shows the location of the ten “Distressed Areas” identified.

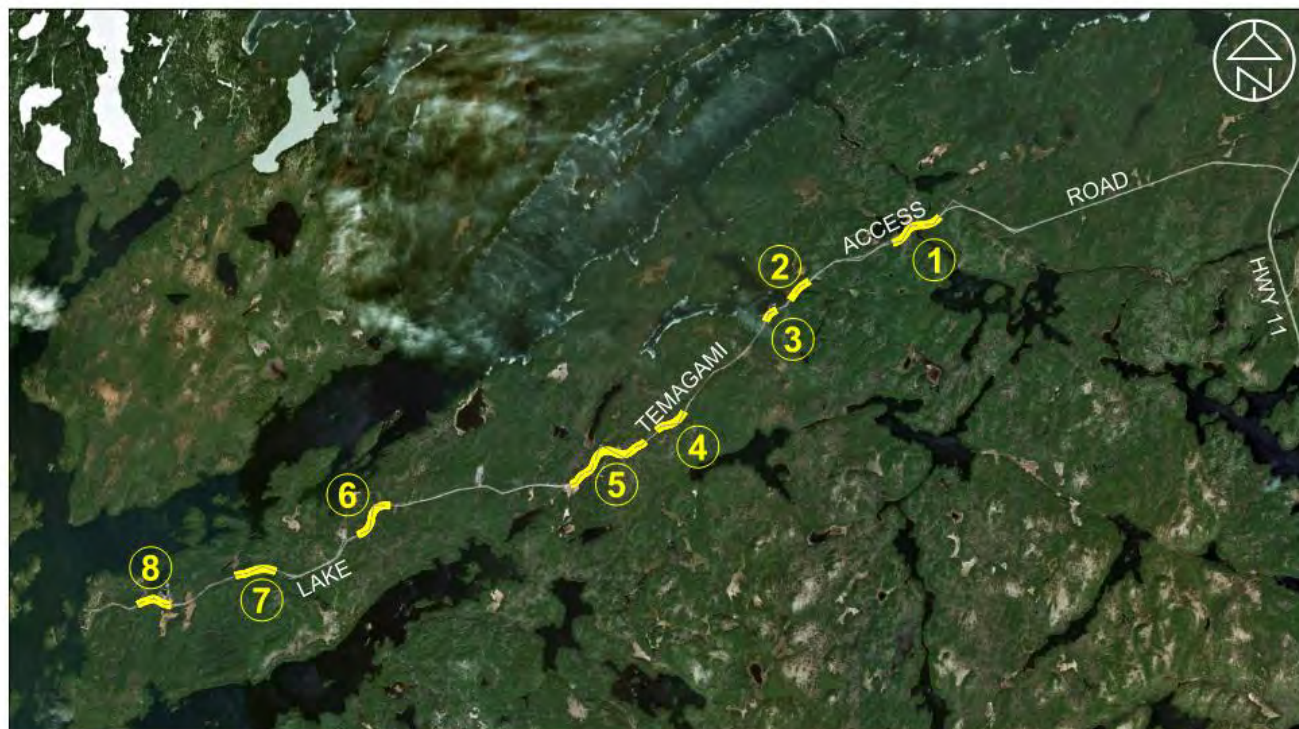
Figure 3 – Horizontal Realignment Area Location Plan  
N.T.S.

Per Table C3-5 of the *Geometric Design Standards for Ontario Highways, 2002* the minimum curve radius for a secondary highway with a design speed of 80 km/h is 250m. Based on this minimum radius, 22 of the 50 curves identified in **Table 2** are substandard\*.

Eight areas requiring horizontal realignment were identified, they are shown in the figure below.
