Structural Inspection Report

Caribou Mountain Tower

Temagami, Ontario

P-SEC Project Number 17510

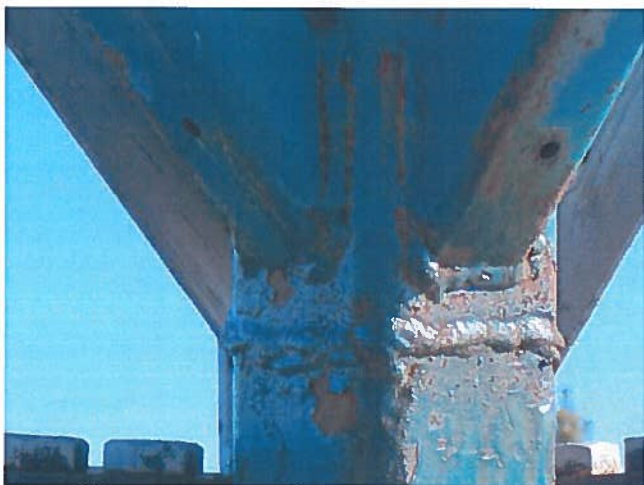
Deficiency #7
Weep holes have not been installed on the majority of the members throughout the tower.

Example of installed weep hole

Recommendation
Based on the presence of (2) diagonal members that appear to have split installing weep holes at the bottom end of all continuous HSS members should be considered.

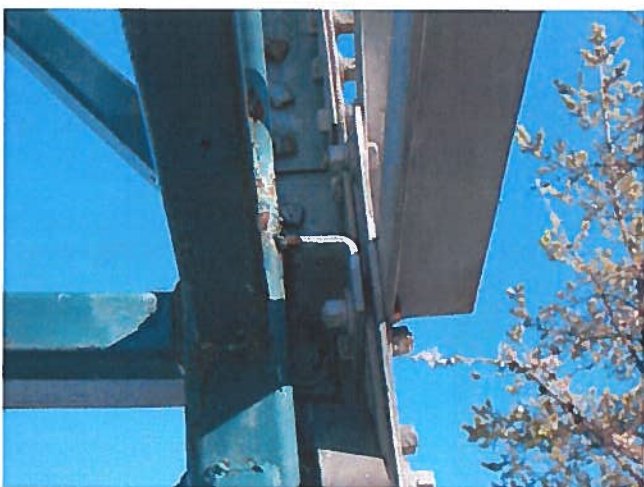
Example of installed weep hole
